## AQUILA, MICHOACÁN, MEXICO SEPTEMBER 19, 2022, $M_w$ 7.6 EARTHQUAKE

### PRELIMINARY VIRTUAL RECONNAISSANCE REPORT (PVRR)

Virtual Earthquake Reconnaissance Team (VERT) Lead:  
Eduardo Miranda, Stanford University

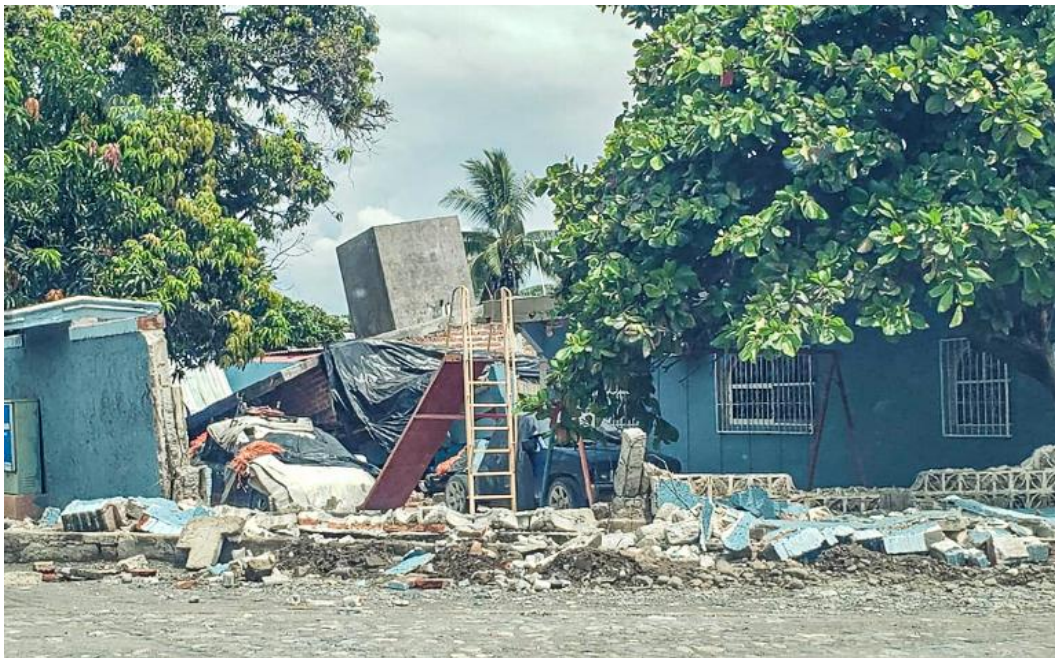
The images of collapsed residential buildings (Figure 7.1 - Figure 7.3) show vulnerable unreinforced masonry (URM) structures, which are known to have low in-plane and out-of-plane displacement capacity. There were also cases of severe URM damage in the form of shear failure of short piers due to the low in-plane masonry strength (Figure 7.4), collapsed roofs (Figure 7.5), and cracked walls (Figure 7.6). Reinforced concrete building collapses also occurred possibly due to system irregularities and non-ductile concrete characteristics (Figure 7.7 and Figure 7.8). Intact columns are observed in Figure 7.7, indicating potential failure of beam-column joints, leading to collapse.

**Figure 7.1. Collapsed building in Coahuayana, Michoacán (El Sol de Morelia, 2022a).**

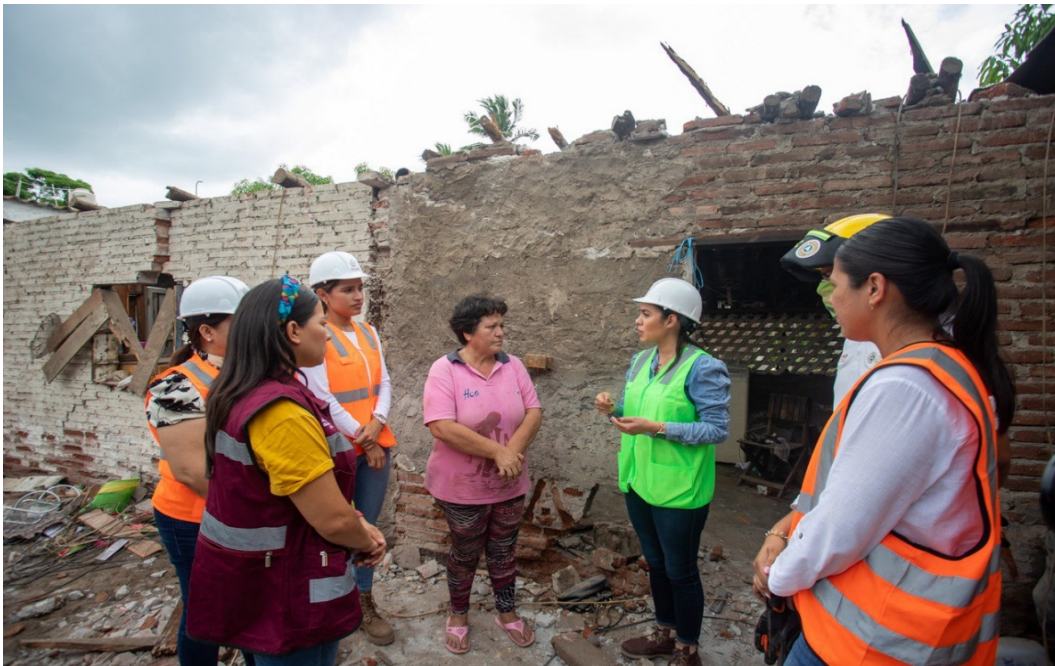
**Figure 7.5. Single-family building in Armería, Colima with collapsed wooden roof. The state governor visited affected regions. Many single-family buildings are made of unreinforced masonry, which are highly vulnerable to ground motions. This type of damage is typical in the affected regions (Facebook, 2022c)**

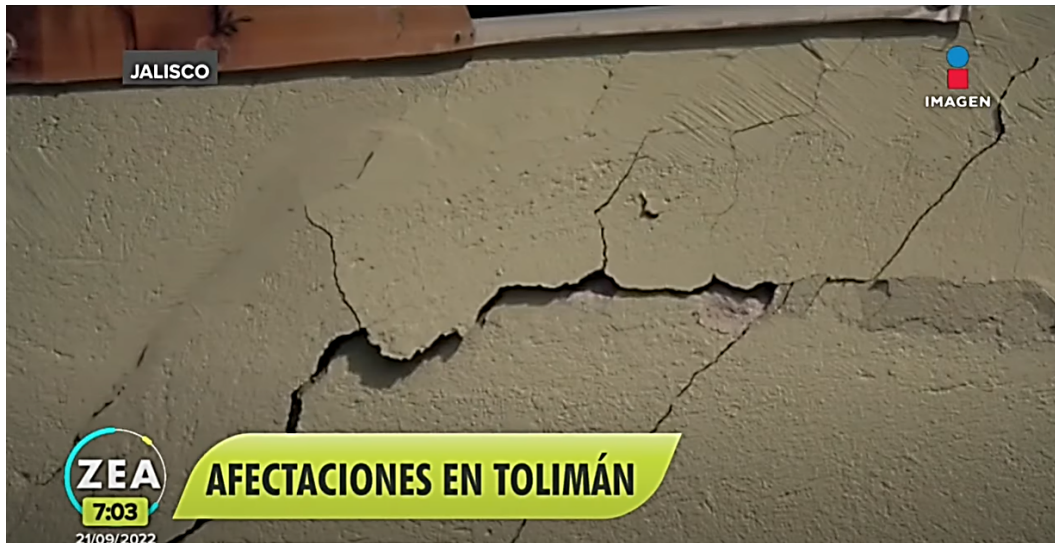
Figure 7.6. Cracking wall in a unreinforced masonry house in Tolimán, Colima (Imagen Noticias, 2022)

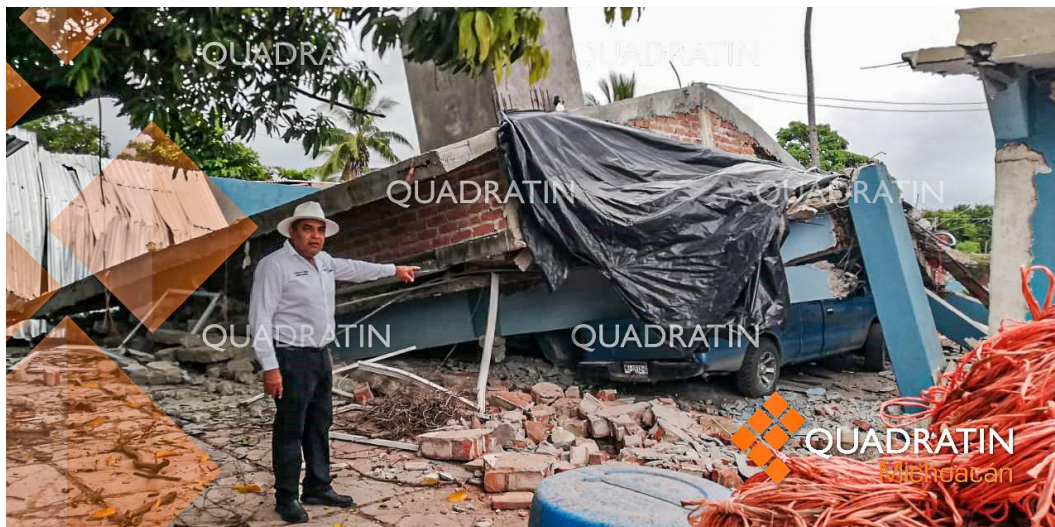
Figure 7.7. Total collapse of a reinforced concrete single-family building with masonry infill walls in San Vicente, Michoacán (Twitter, 2022c).

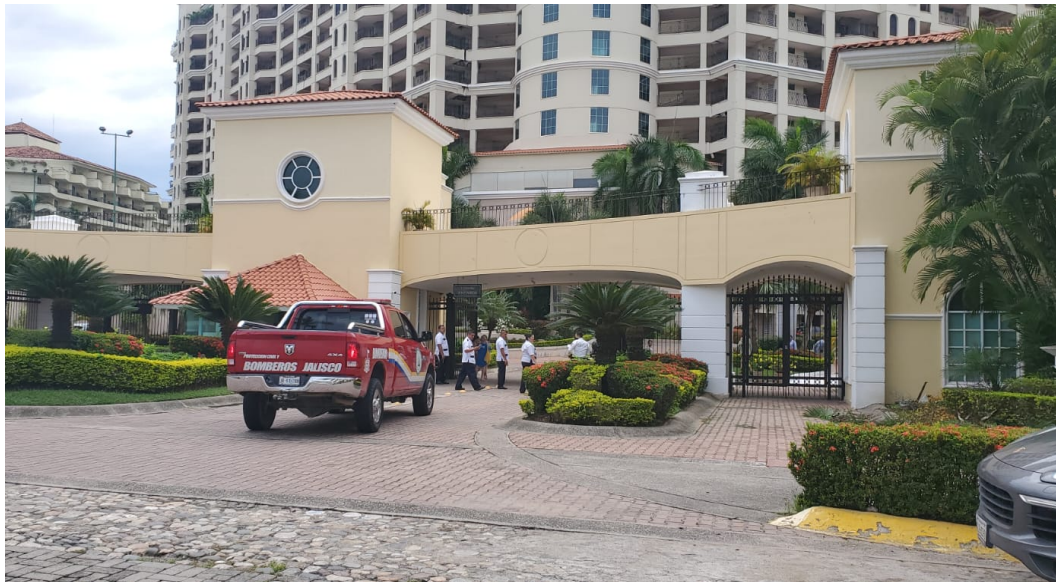
**Figure 7.9. Portofino Condominium, Puerto Vallarta, Jalisco. No structural damage was observed. Only minor damage to ceilings, partition walls and ornaments was reported (Contralinea, 2022)**

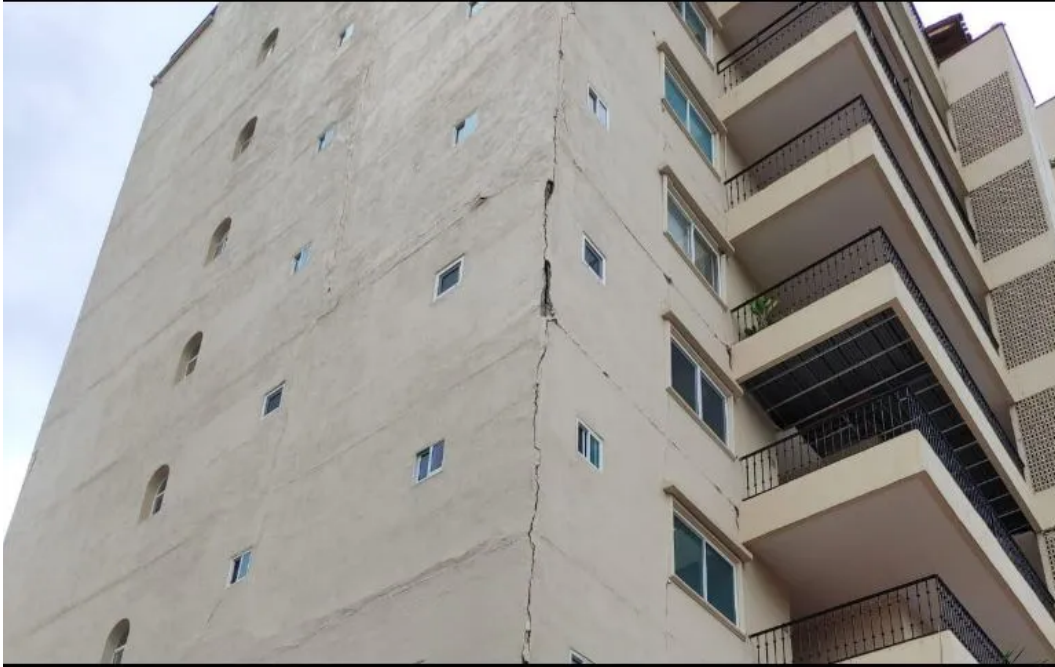
**Figure 7.10. Tres Mares Condominium in Puerto Vallarta, Jalisco. Only nonstructural damage was observed and mainly occurred in facades, tiles and ceilings (Informador.Mx, 2022).**

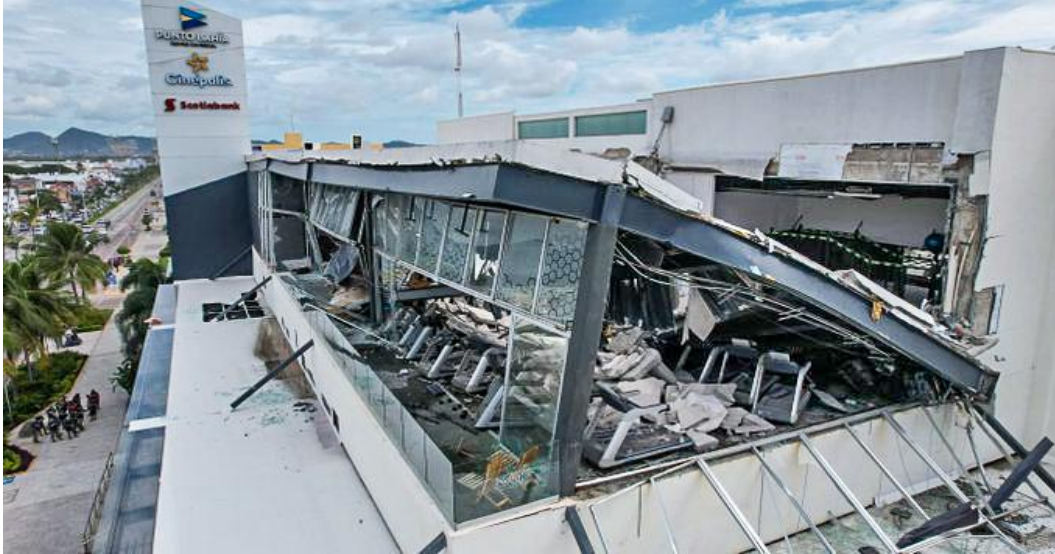
Many commercial buildings experienced damage. The collapsed roof at Plaza Punto Bahia is one of the most relevant as it caused the death of one occupant. According to the pictures in Figure 7.11 to Figure 7.13, the steel structure seems to have failed when the beams detached from the concrete structure during the earthquake (Figure 7.11). The other case which also resulted in a fatality was the out-of-plane partial collapse of the facade of the Valle de Garzas store as shown in Figure 7.14 to Figure 7.16. It is likely that the heavy masonry sections that fell were not effectively anchored to the main structure.

Figure 7.11. Collapsed roof in Plaza Punto Bahía in Manzanillo, Colima (Twitter, 2022d).

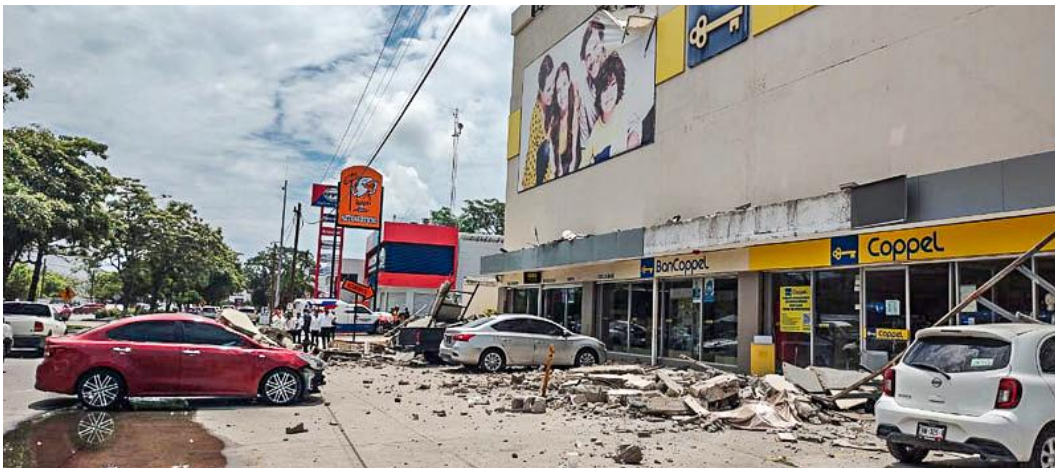
**Figure 7.14. Out-of-plane wall failure in the Coppel store at Valle de las Garzas in Manzanillo, Colima (Diario de Colima, 2022b)**

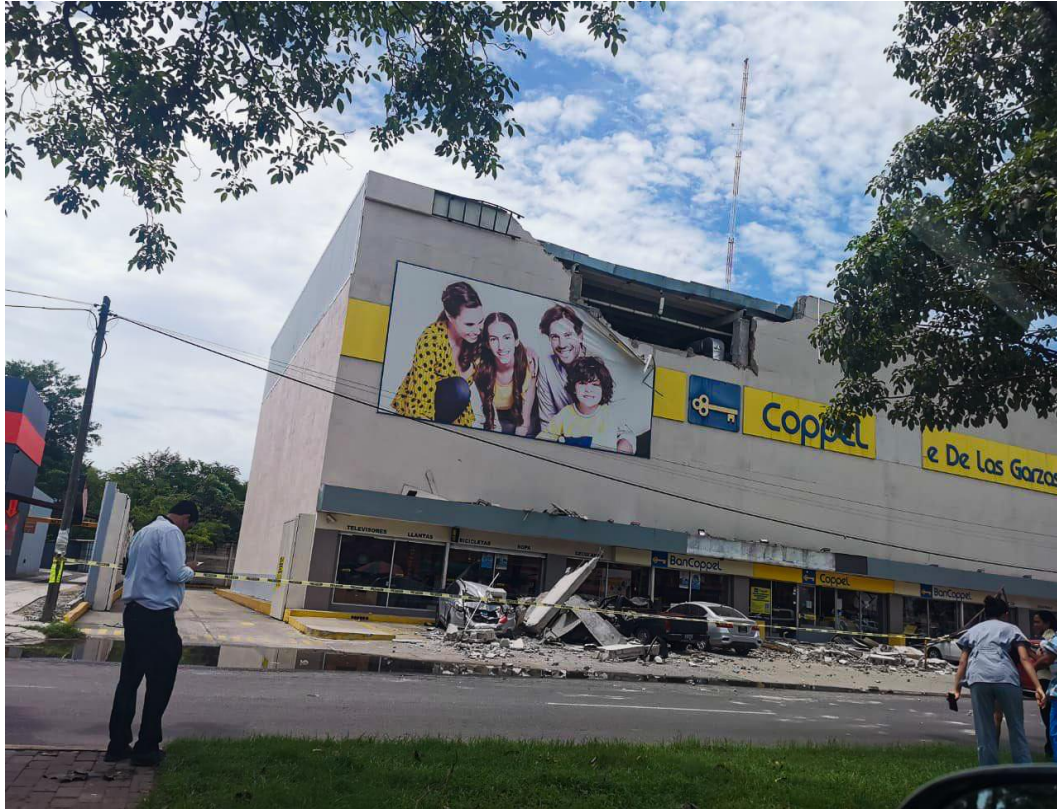
**Figure 7.15. Out-of-plane wall failure in the Coppel store at Valle de las Garzas in Manzanillo, Colima which resulted in one fatality (Twitter, 2022e).**

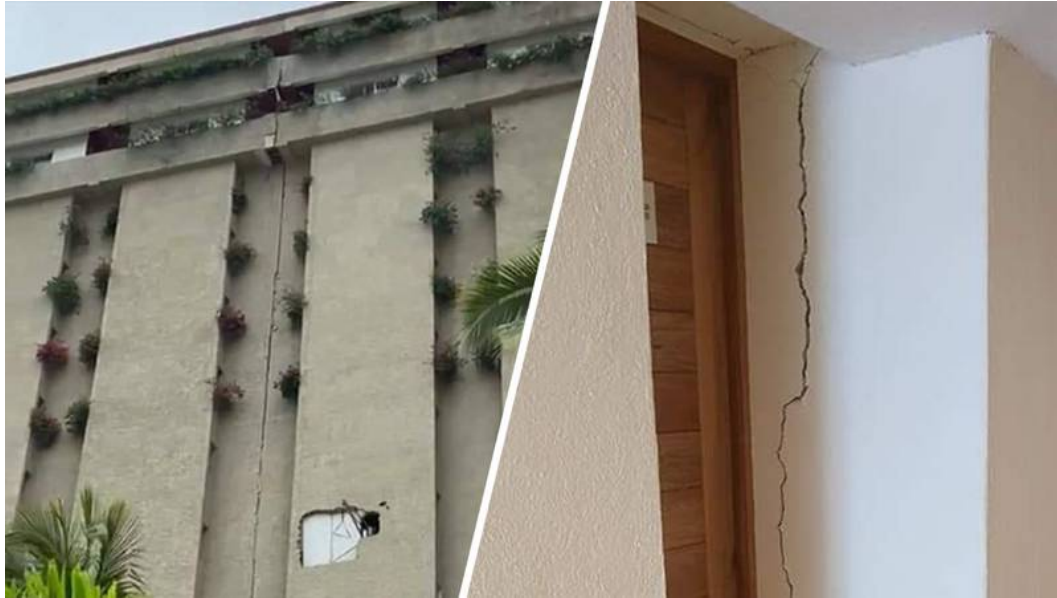
**Figure 7.17. Sheraton Buganvillas hotel, Puerto Vallarta, Jalisco. Damage in facades and interior walls. (El Financiero, 2022a).**

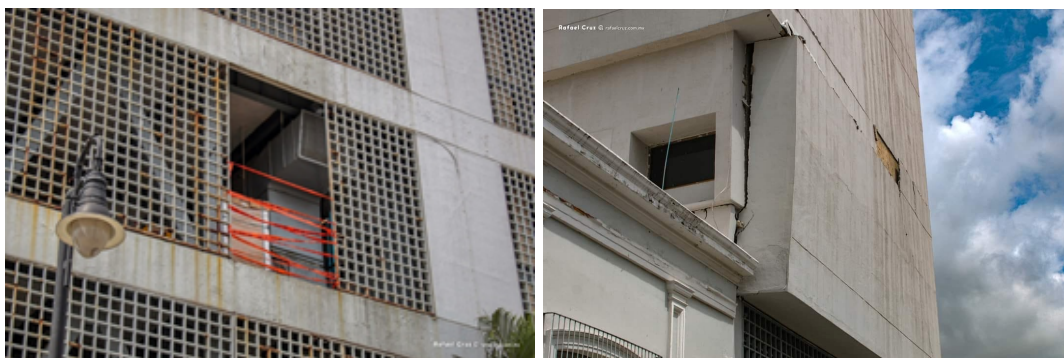
**Figure 7.18. Damage on Telmex building in Colima, Colima: left (Credits: Rafael Cruz, Facebook 2022f) right (Credits: Rafael Cruz, Facebook 2022e); .**

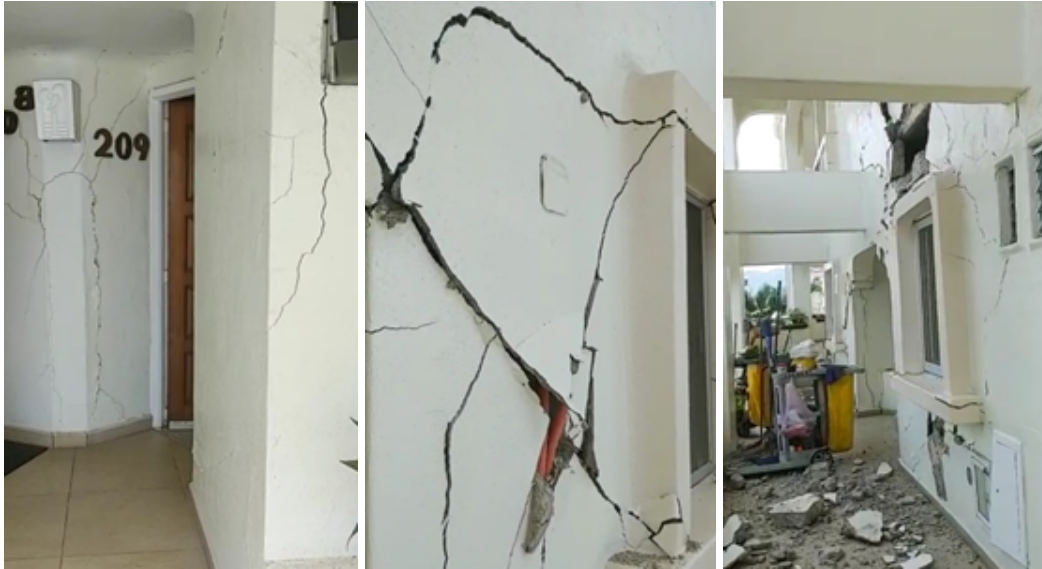
Figure 7.19. Severe wall damage in Gran Pacífico Hotel in Manzanillo, Colima (Colima Noticias, 2022).

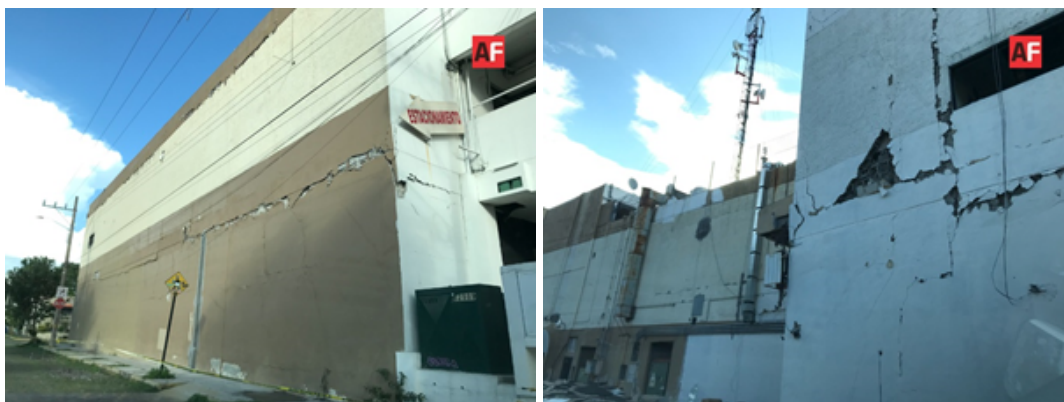
Figure 7.20. Severe cracking on the facade of Plaza Country in Colima, Colima (Facebook, 2022g).

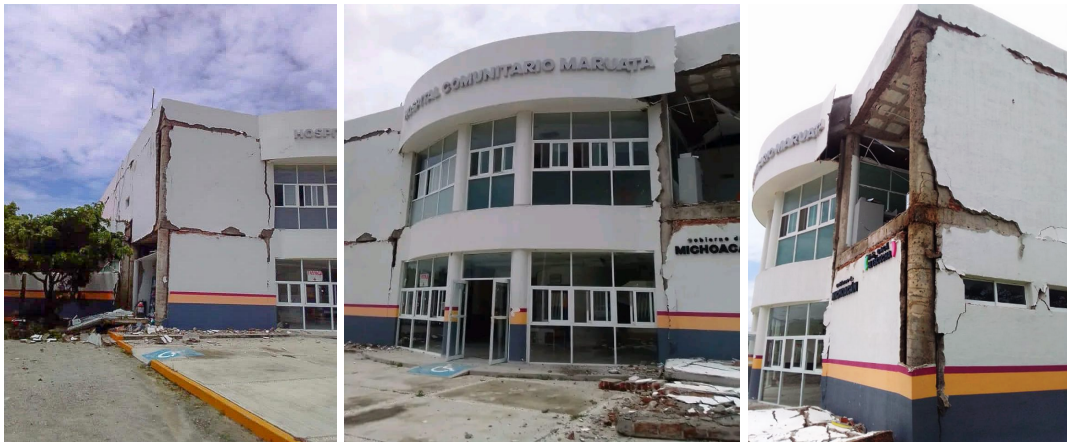
Figure 7.22. Exterior of the Maruata Hospital, Maruata, Michoacán after the earthquake: Masonry facade collapse, exposing significant steel corrosion in columns (Twitter, 2022g)

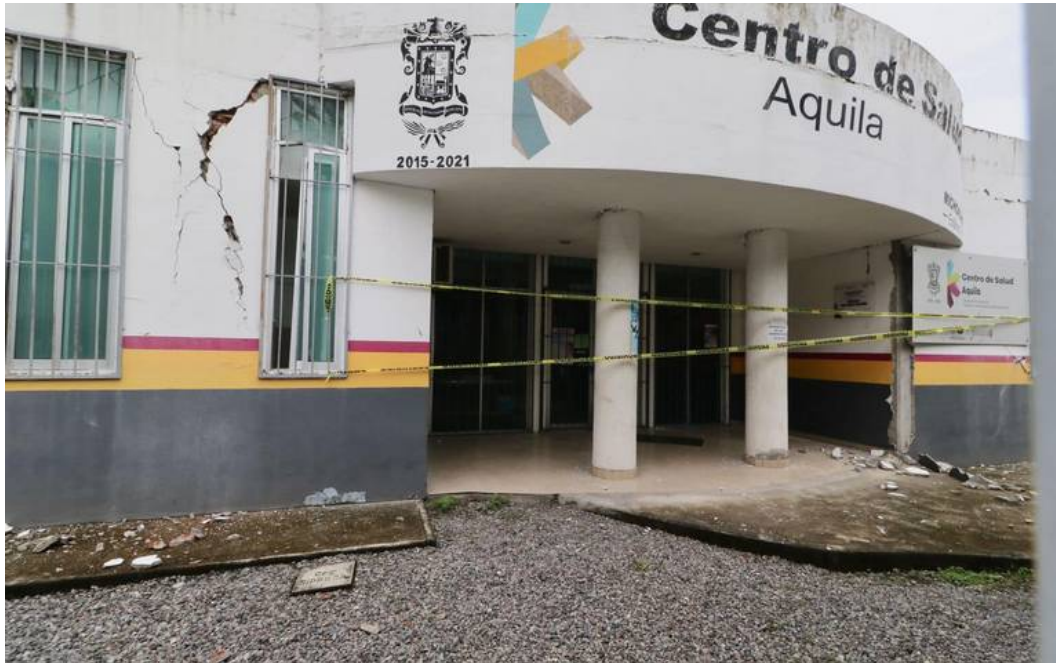
**Figure 7.23. Health center at Aquila, Michoacán. The building was evacuated due to structural damage. (El Sol de Morelia, 2022b)**

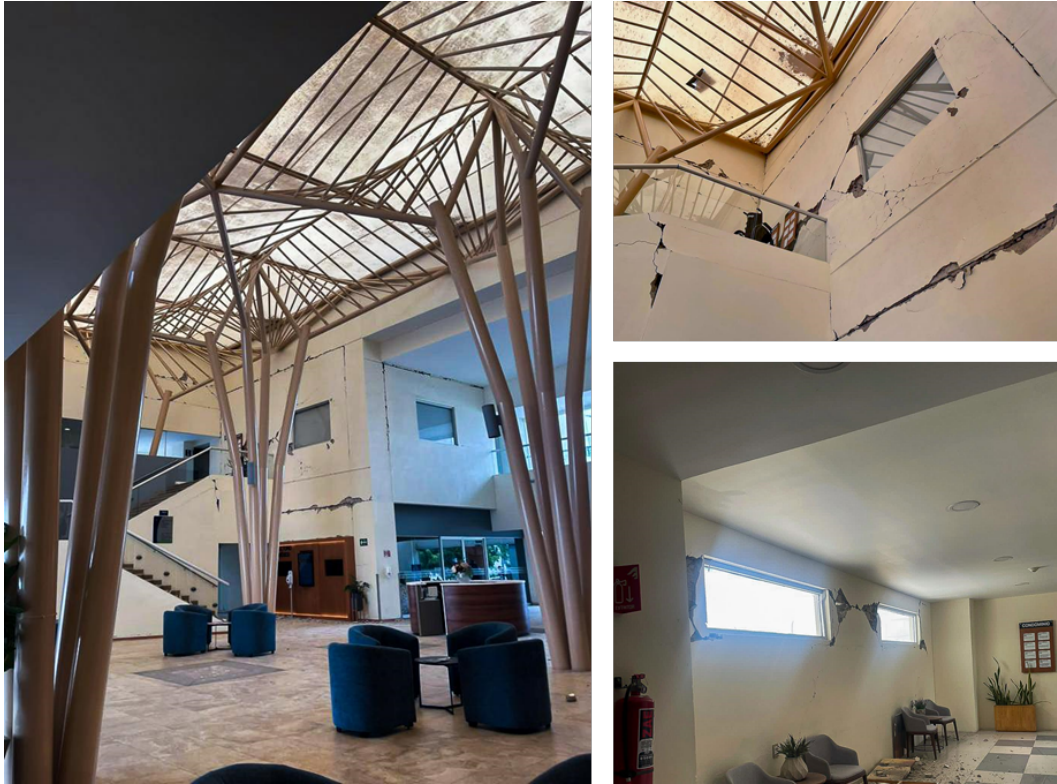
**Figure 7.24. Damage to walls of the Hospital Puerta de Hierro in Colima, Colima (Twitter, 2022k).**

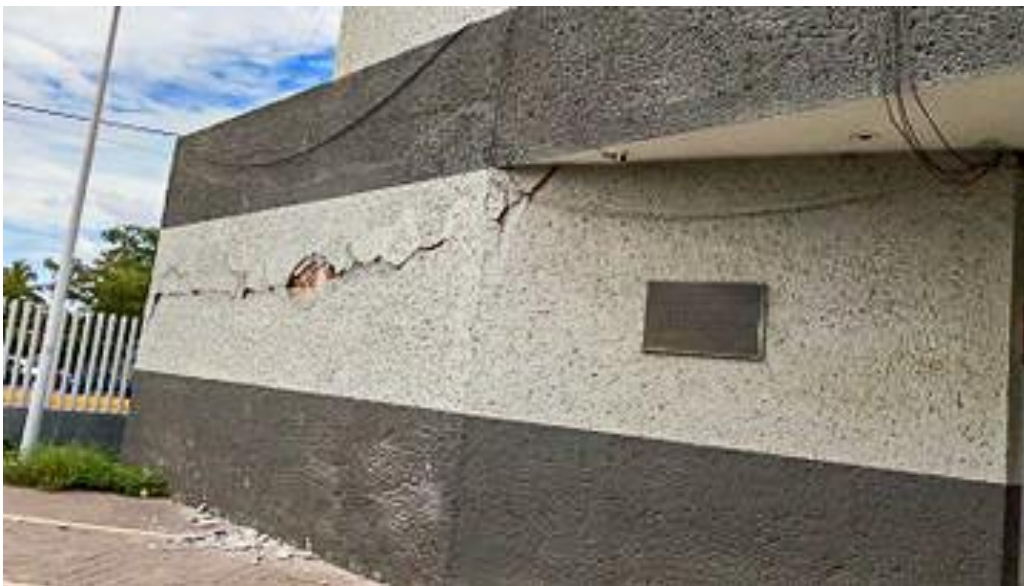
**Figure 7.25. Cracked walls of the Institute of Security and Social Services for State Workers, which is a major government health services provider in Mexico for government employees and their families (ISSSTE) in Apatzingán, Michoacán (Twitter, 2022j).**

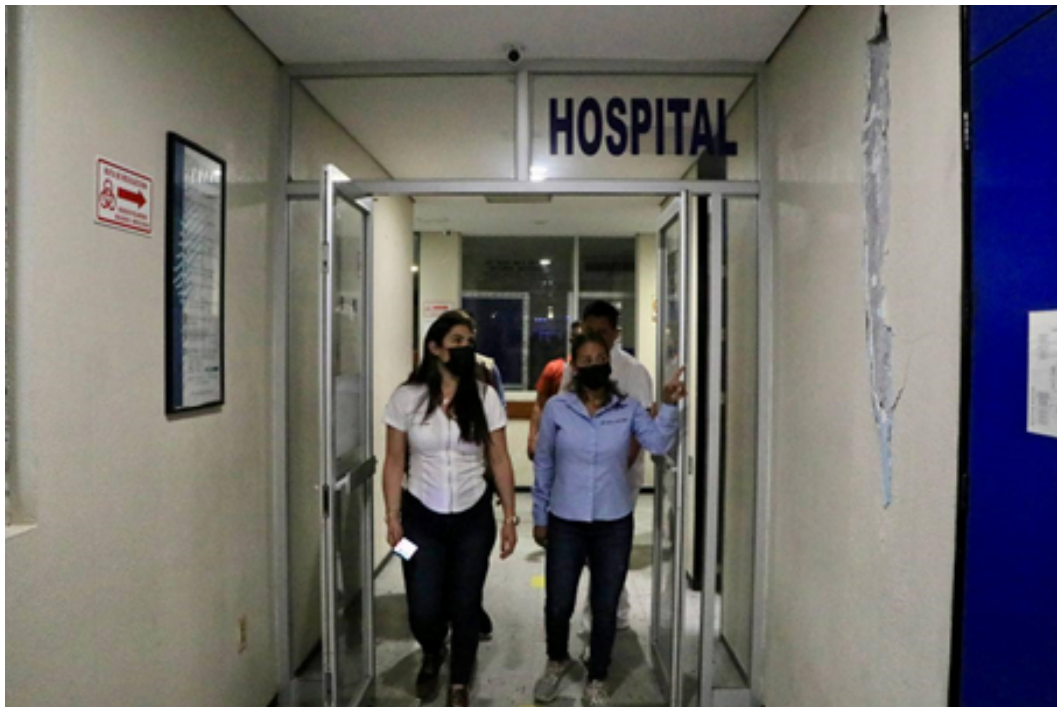
Figure 7.26. Minor cracking in Tecomán General Hospital in Colima (Twitter, 2022h).

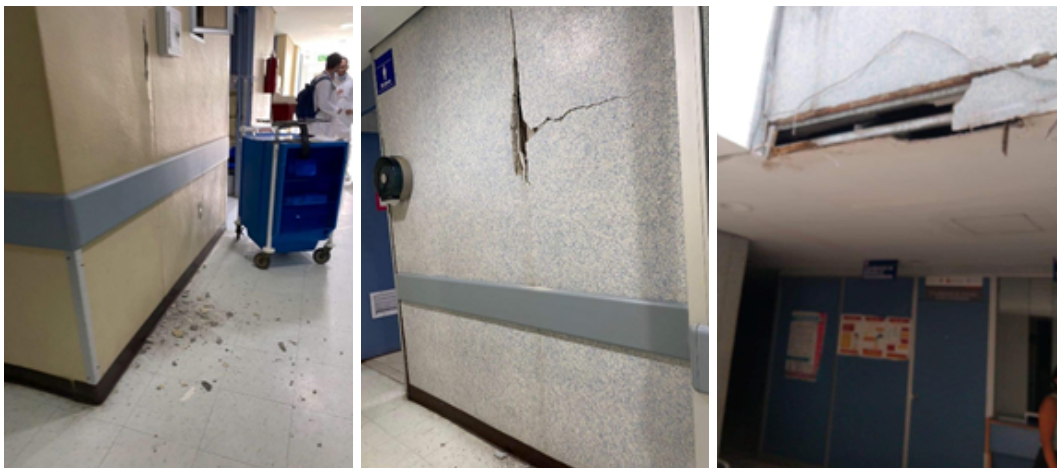
Figure 7.27. Damage in ISSSTE Hospital "Dr. Miguel Trejo Ochoa" in Colima, Colima: left (Facebook, 2022h); center (Facebook, 2022i); right (Facebook, 2022j).

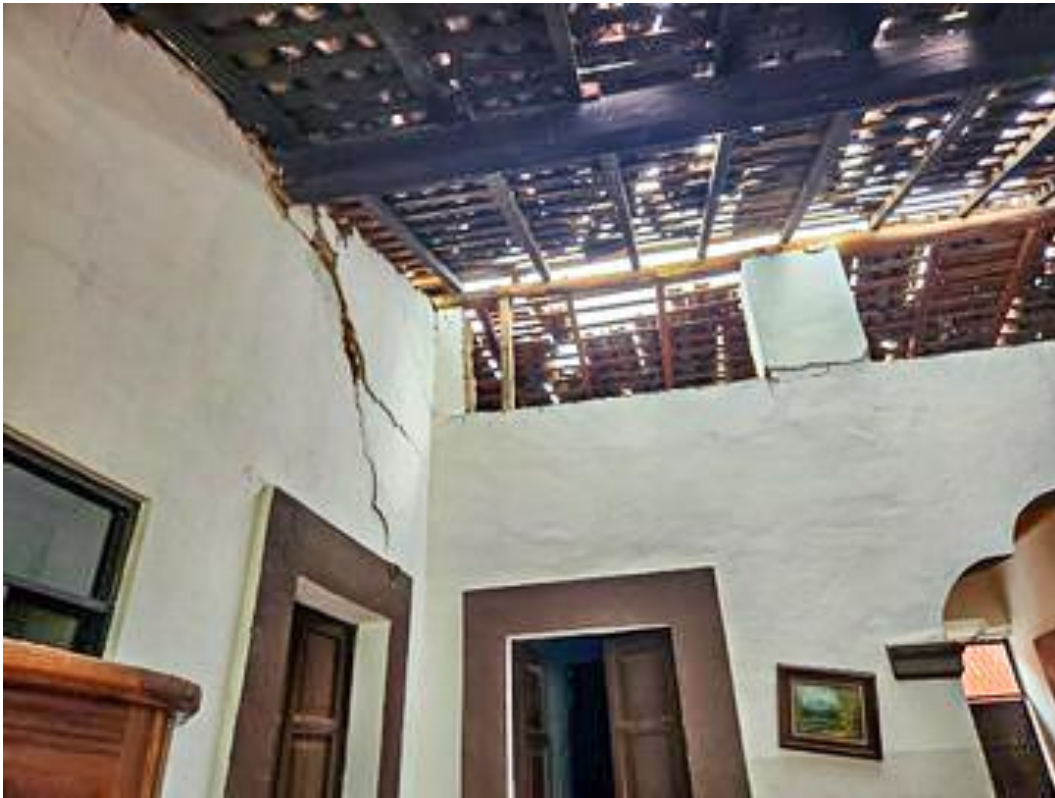
Figure 7.28. Damage to roof and walls in historical buildings in Coalcomán, Michoacán (Twitter, 2022w)

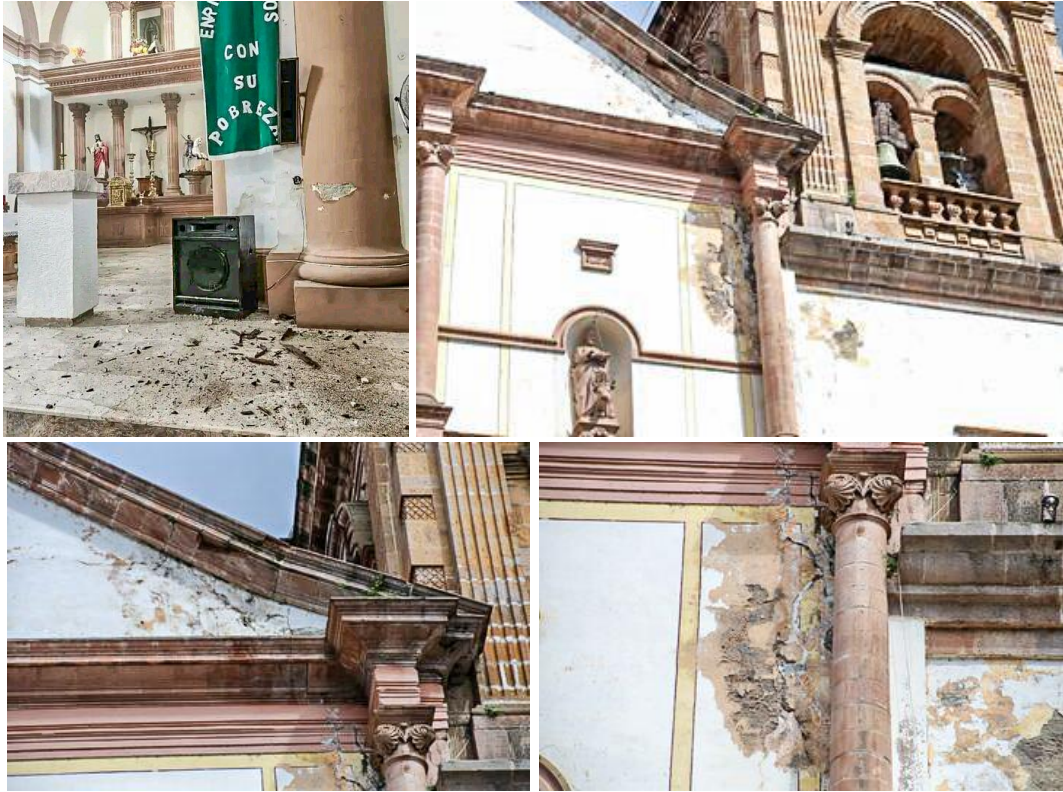
**Figure 7.29. Cracks in the Basilica de Nuestra Señora de la Salud in Patzcuaro, Michoacán (Twitter, 2022i).**

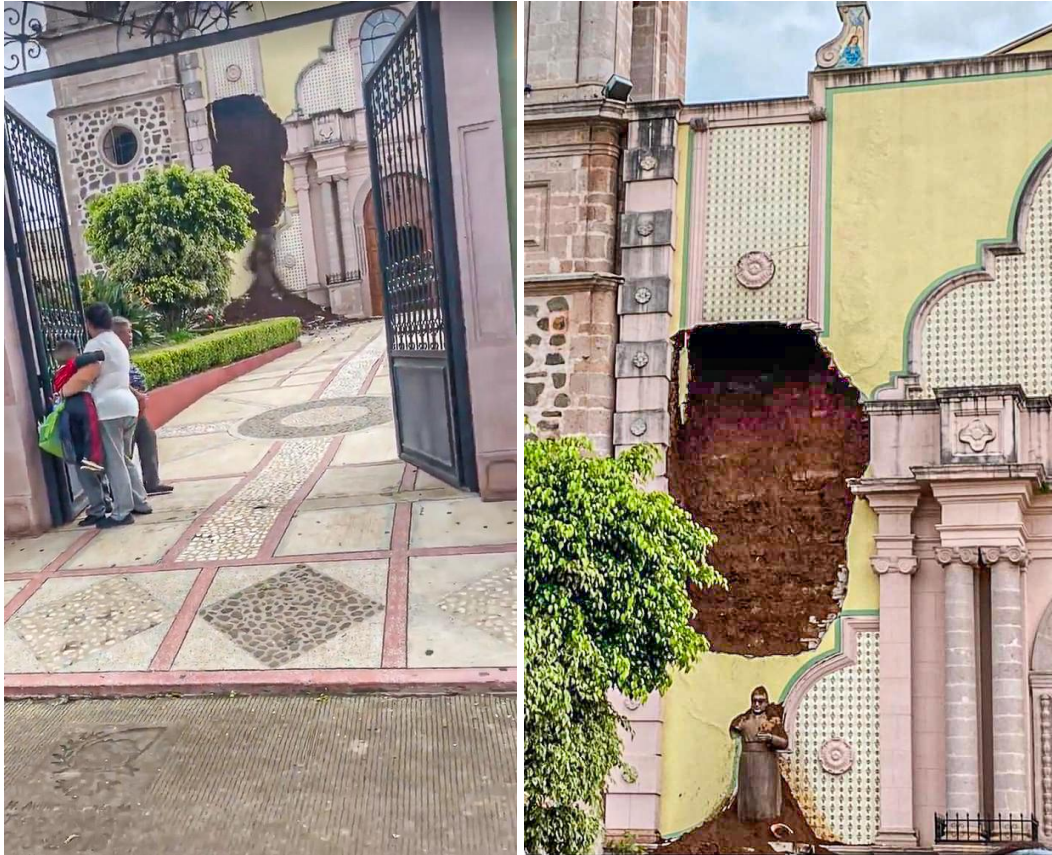
**Figure 7.30. Damage caused by the earthquake is observed in the church of San Miguel Arcángel in Tacatzcuaro, Michoacán (Facebook, 2022b)**

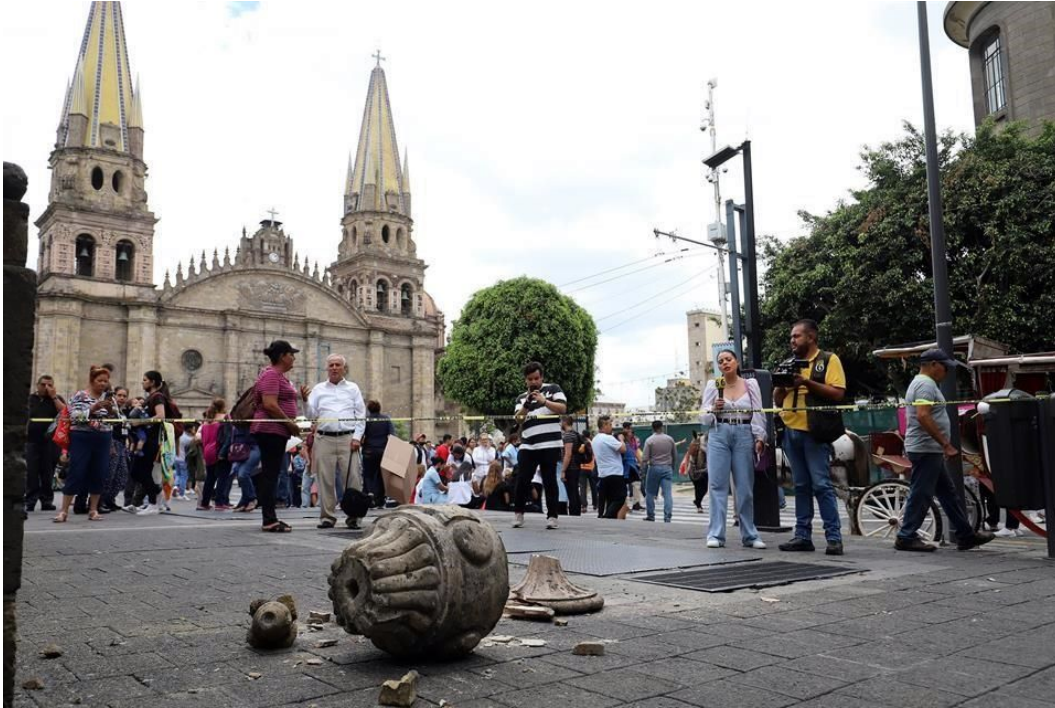
**Figure 7.31. Detachment of an ornamentation in the La Merced Church in downtown Guadalajara, Jalisco (Reforma, 2022)**

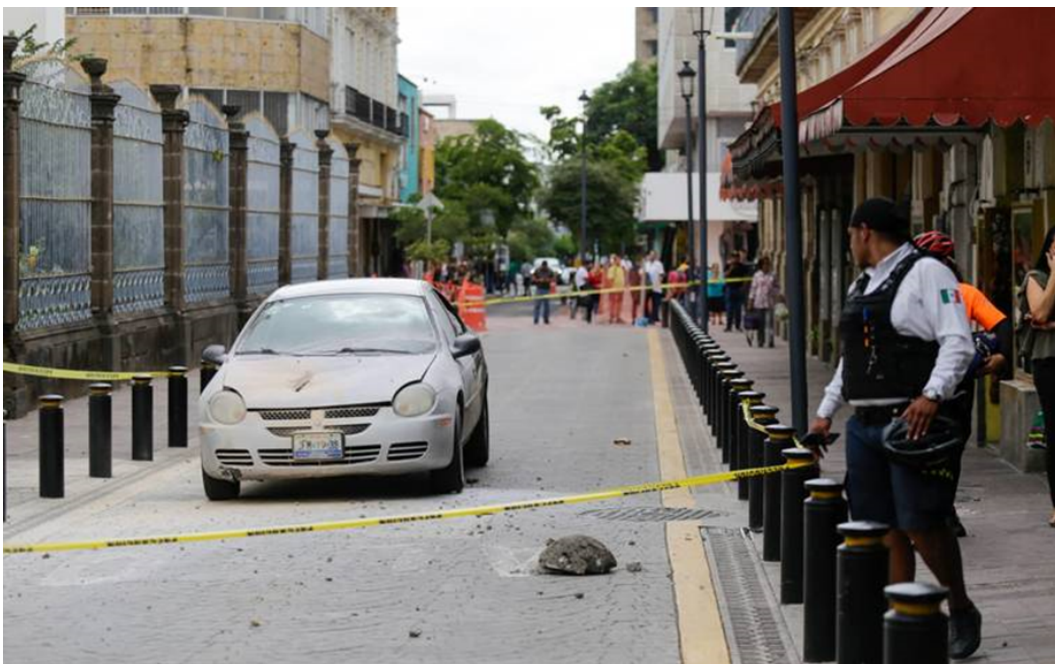
**Figure 7.32. Detachment of an ornamentation in San Agustín Church in downtown Guadalajara, Jalisco (El Occidental, 2022)**

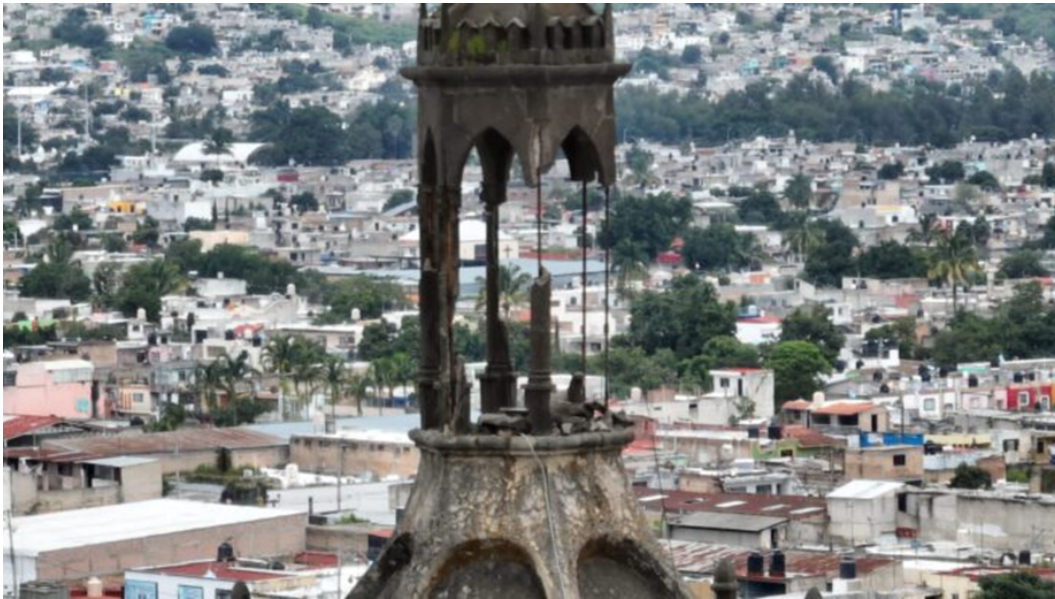
**Figure 7.33. Damage at the upper portion of the bell tower in the Asunción Maria Cathedral in Tepic, Nayarit (Meridiano.mx, 2022)**

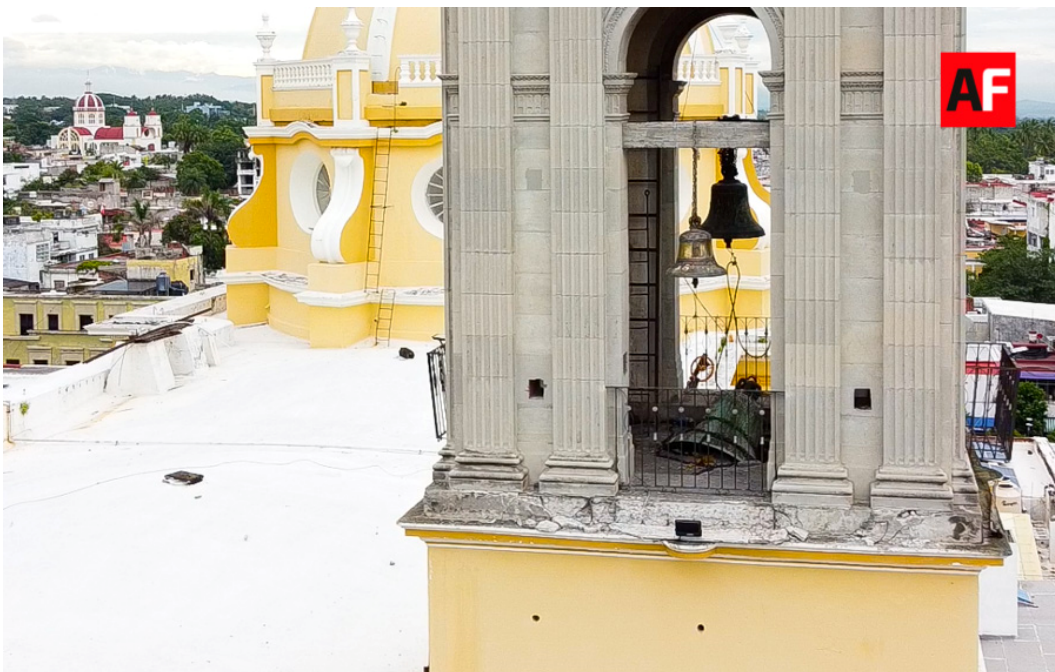
**Figure 7.34. Damage on the bell tower of the Minor Basilica Cathedral of Colima, Colima (AFmedios, 2022a).**

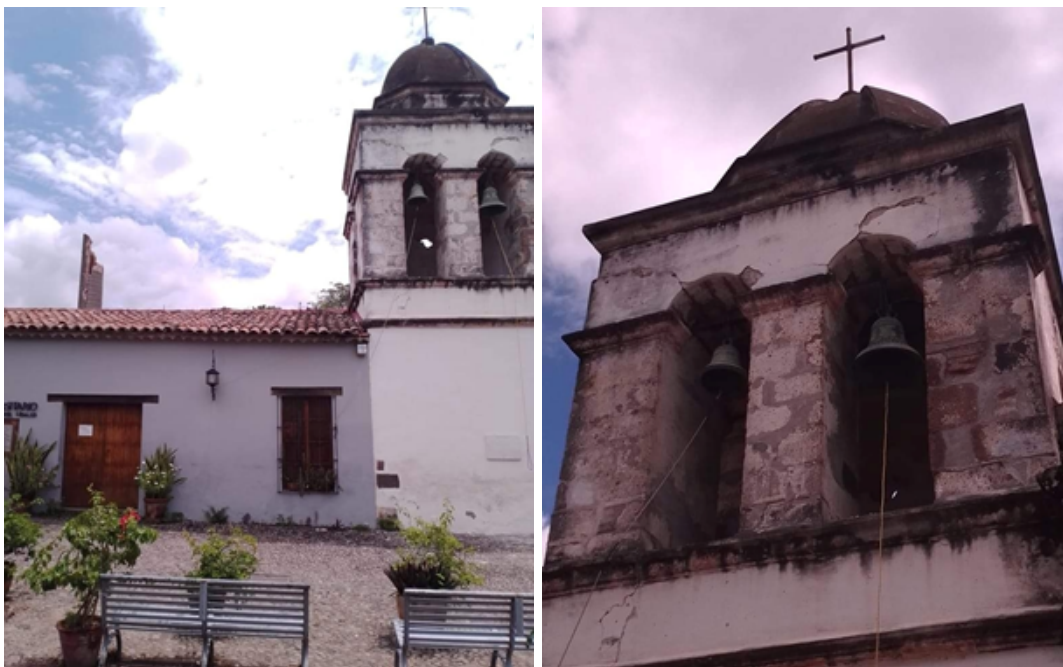
Figure 7.36. Damage on the bell tower of the Noguerras Church in Colima, Colima (Facebook, 2022).

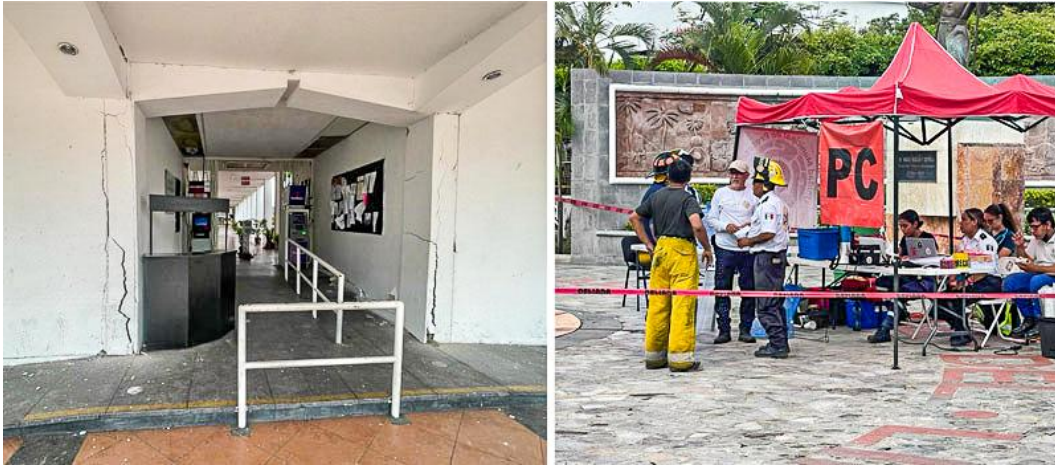
Figure 7.37. Cracks and damaged walls of the “Presidencia municipal de Tecoman” in Michoacán (Diario de Colima, 2022c)

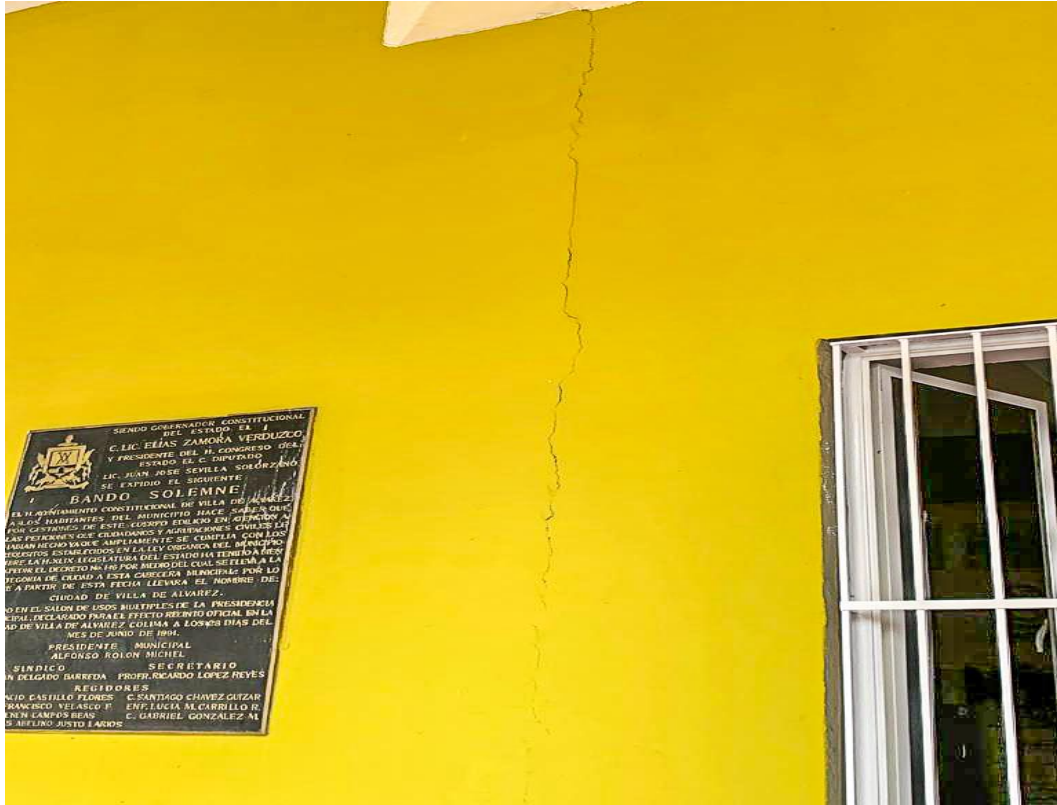
Figure 7.38. Minor cracks in walls of the government building in Villa Alvarez, Colima (Archivo Digital, 2022)

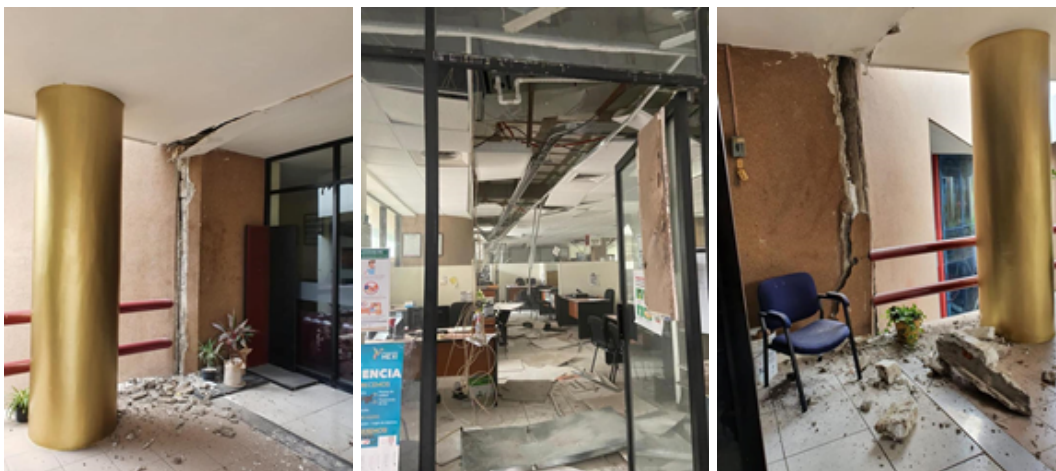
Figure 7.39. Damage in construction joints and ceilings in the Administrative Complex of the Government of the State of Colima: left (Facebook, 2022m); center (Facebook, 2022n); right (Facebook, 2022o)

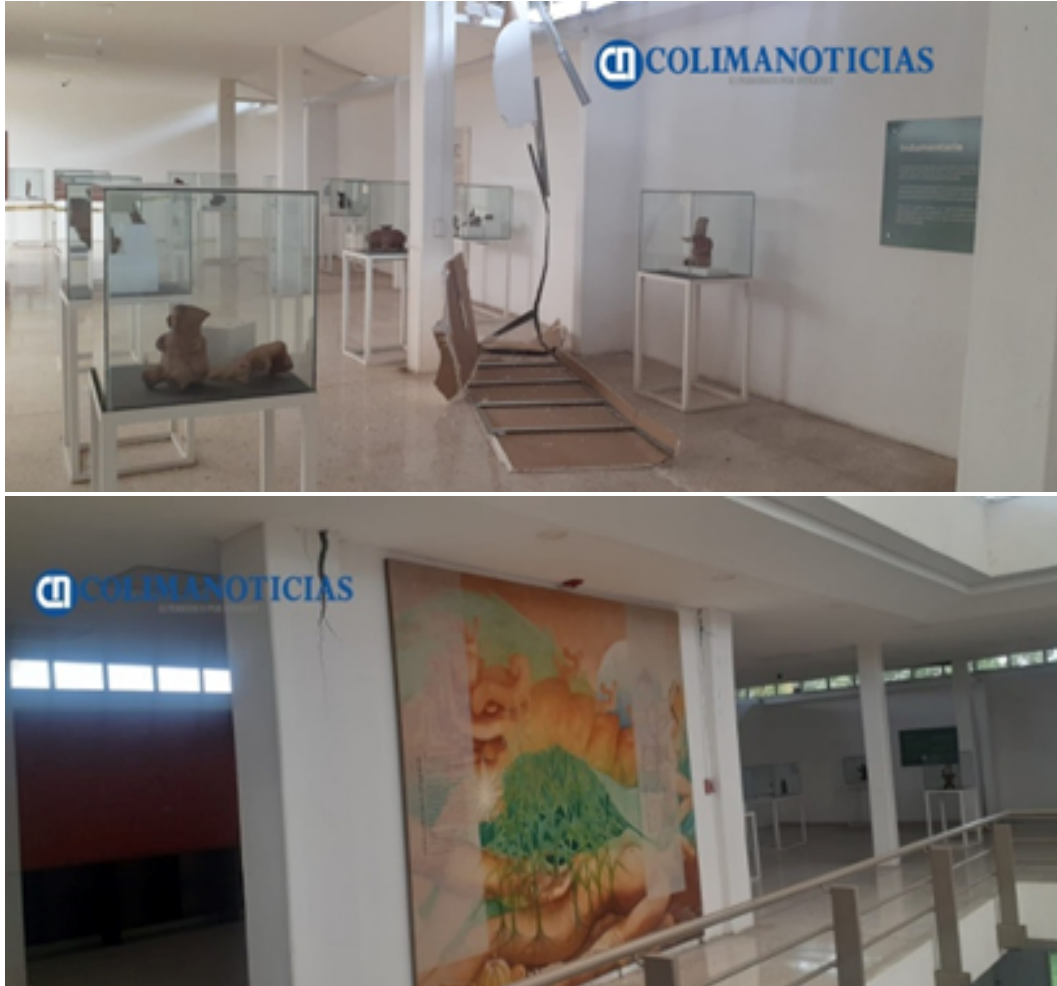
Figure 7.40. Damage to ceilings and severe cracking on walls in the Culturas del Occidente Museum in Colima, Colima (Facebook, 2022p)

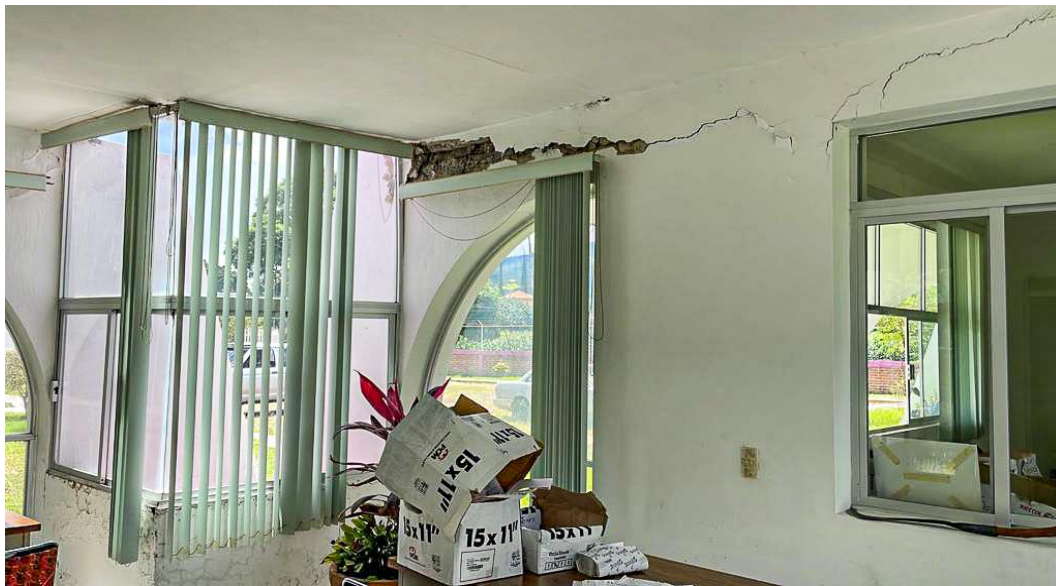
**Figure 7.41. Cracked walls in the school of Jiquilpan, Michoacán (Cambio de Michoacán, 2022).**
