## AQUILA, MICHOACÁN, MEXICO SEPTEMBER 19, 2022, $M_w$ 7.6 EARTHQUAKE

### PRELIMINARY VIRTUAL RECONNAISSANCE REPORT (PVRR)

Virtual Earthquake Reconnaissance Team (VERT) Lead:  
Eduardo Miranda, Stanford University

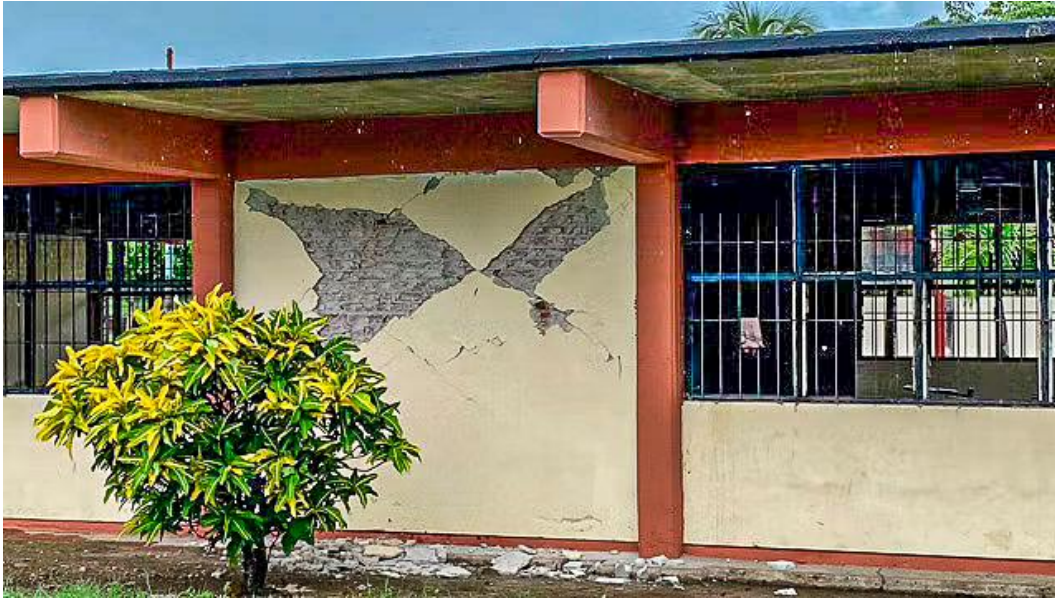
Figure 7.42. Cracked walls of a school in Coalcoman, Michoacán (MiMorelia, 2022).

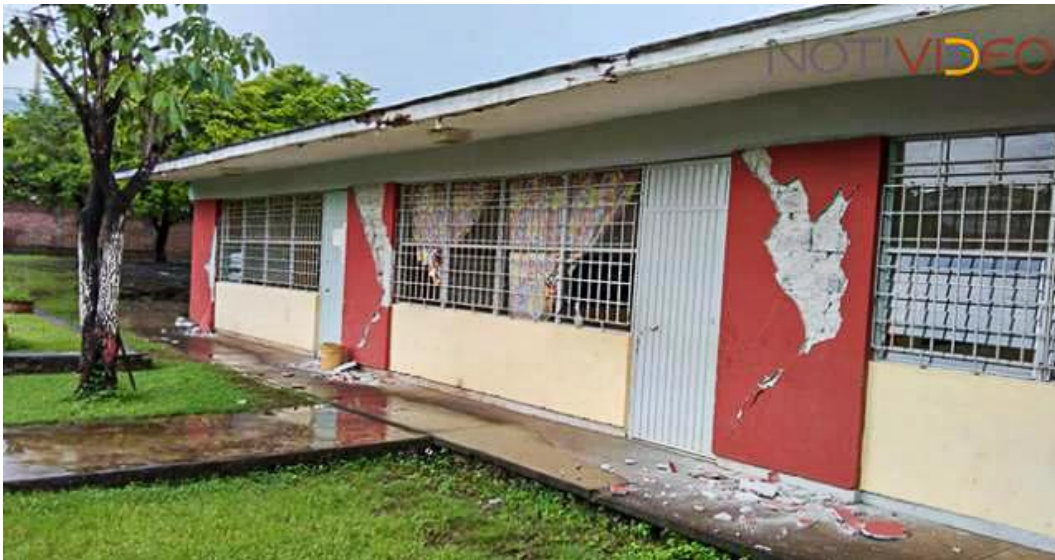
Figure 7.43. Cracked walls of a school in Coalcoman, Michoacán (Notivideo, 2022).

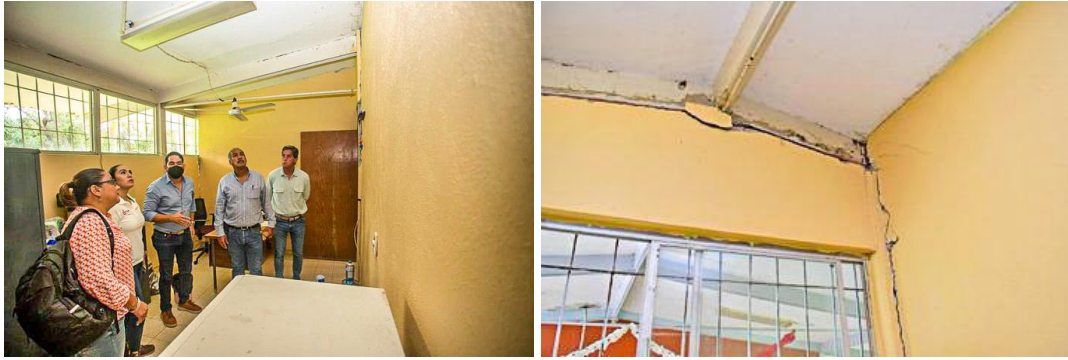
**Figure 7.44. Cracked walls of Macario G. Barbosa school in Tecoman, Colima (Twitter, 2022l)**

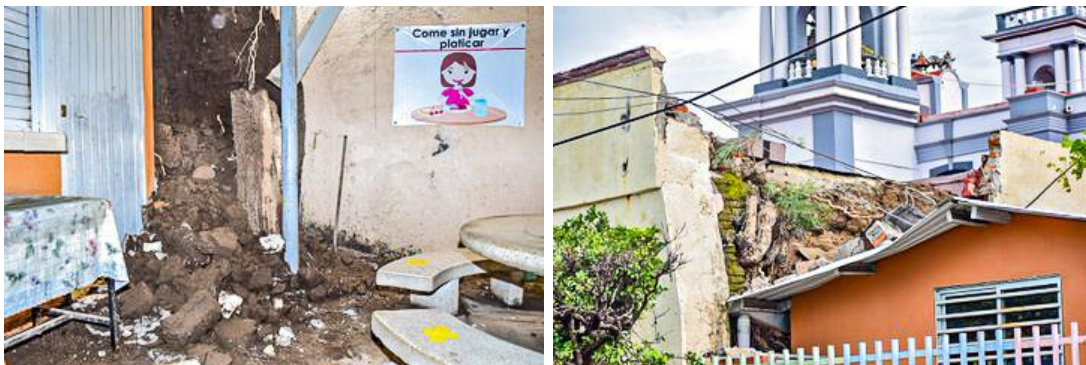
**Figure 7.45. Collapsed walls of neighboring structure next to the kindergarten Joseffina Beas in Coquimatlan Colima (Twitter, 2022m)**

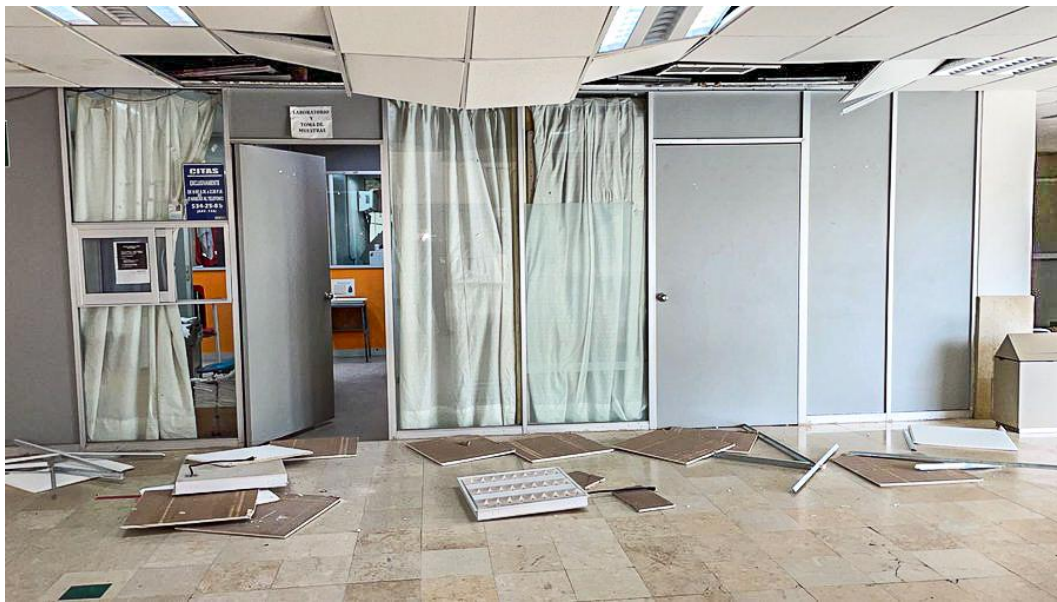
**Figure 7.46. Non-structural damage in the Institute of Security and Social Services for State Workers (ISSSTE) in Apatzingan, Michoacán (Twitter, 2022j).**

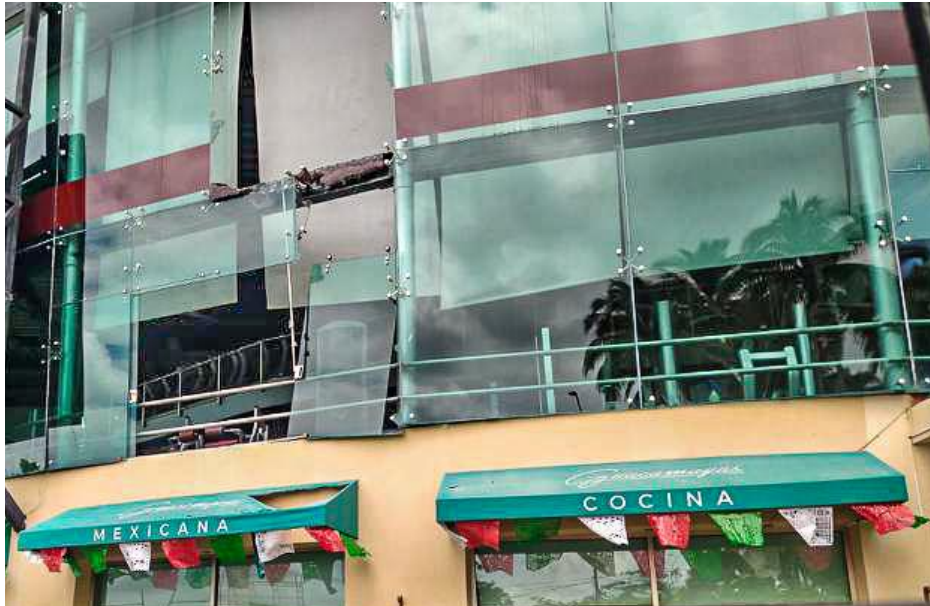
Figure 7.48. Non-structural damage of the mall in Colima, Colima (Publimetro, 2022).

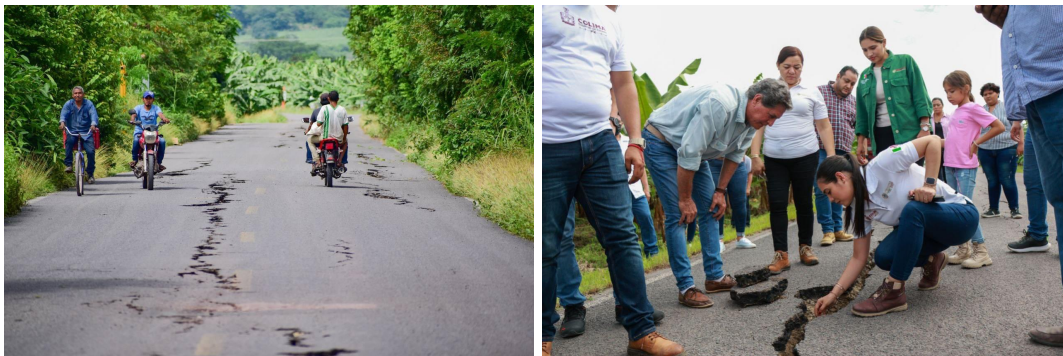
Figure 7.57. Damage in Ortega-Callejones road (K2+000 to K3+300) in Colima. (Twitter, 2022o).

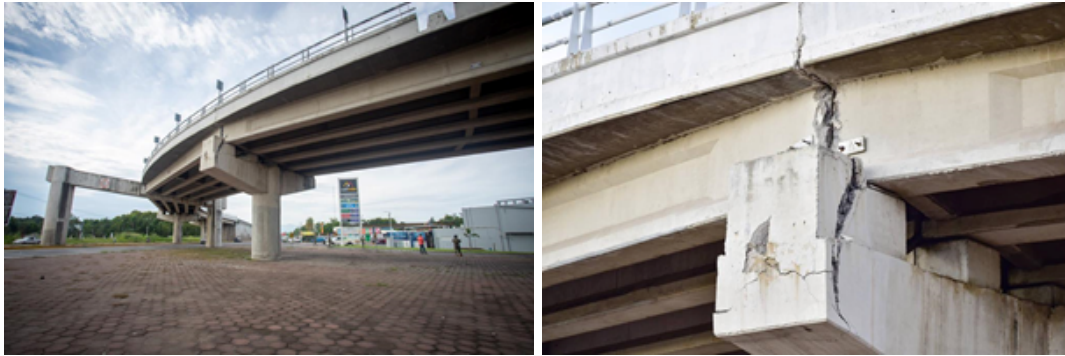
**Figure 7.58. Damage in bridge “Puente Cortés” in Colima, Colima (El Comentario, 2022).**

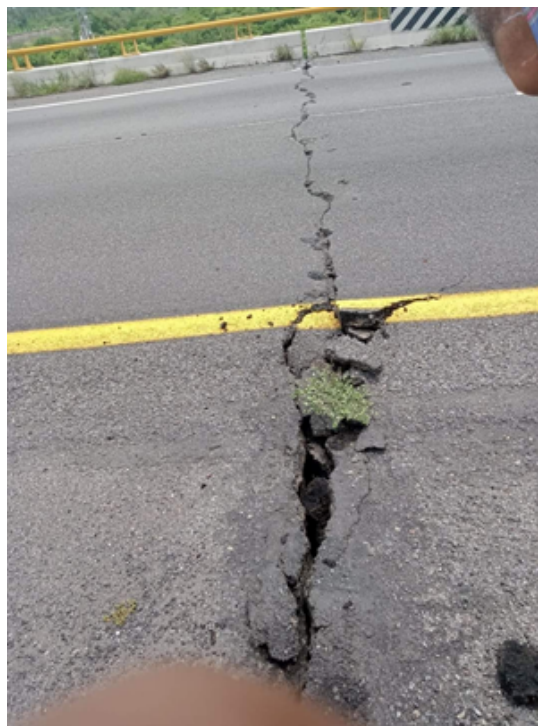
**Figure 7.59. Damage at a joint in the Armería bridge located on the federal highway Colima-Manzanillo en Tecmán, Colima (Facebook, 2022k).**

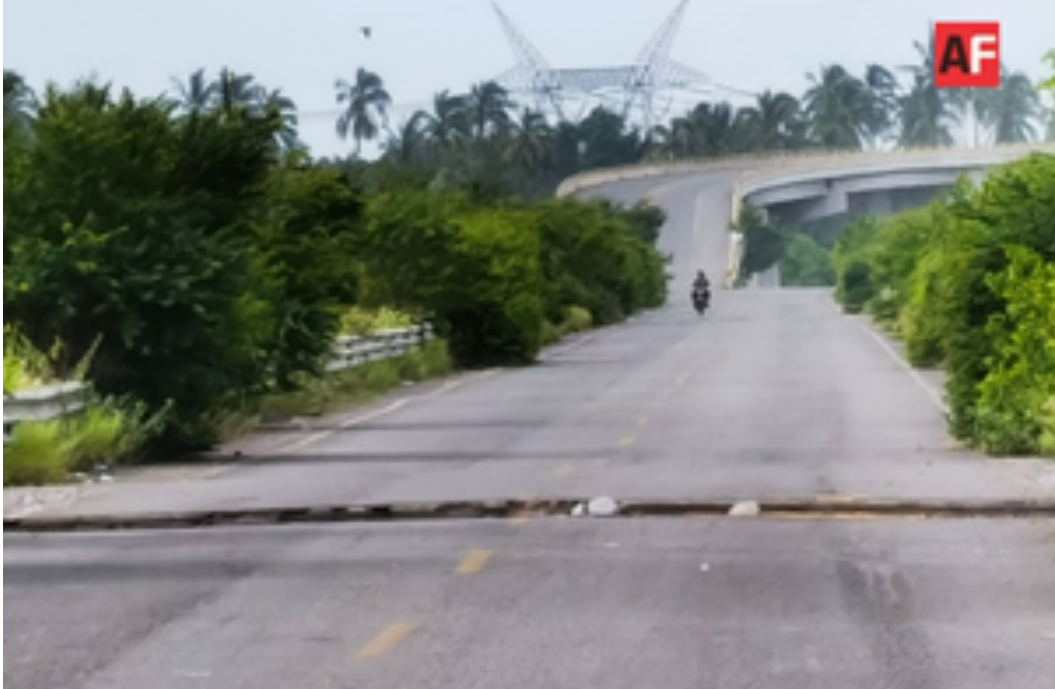
**Figure 7.60. Damage on the Campos-Punta Grande federal highway in Manzanillo, Colima (Afmedios, 2022b).**

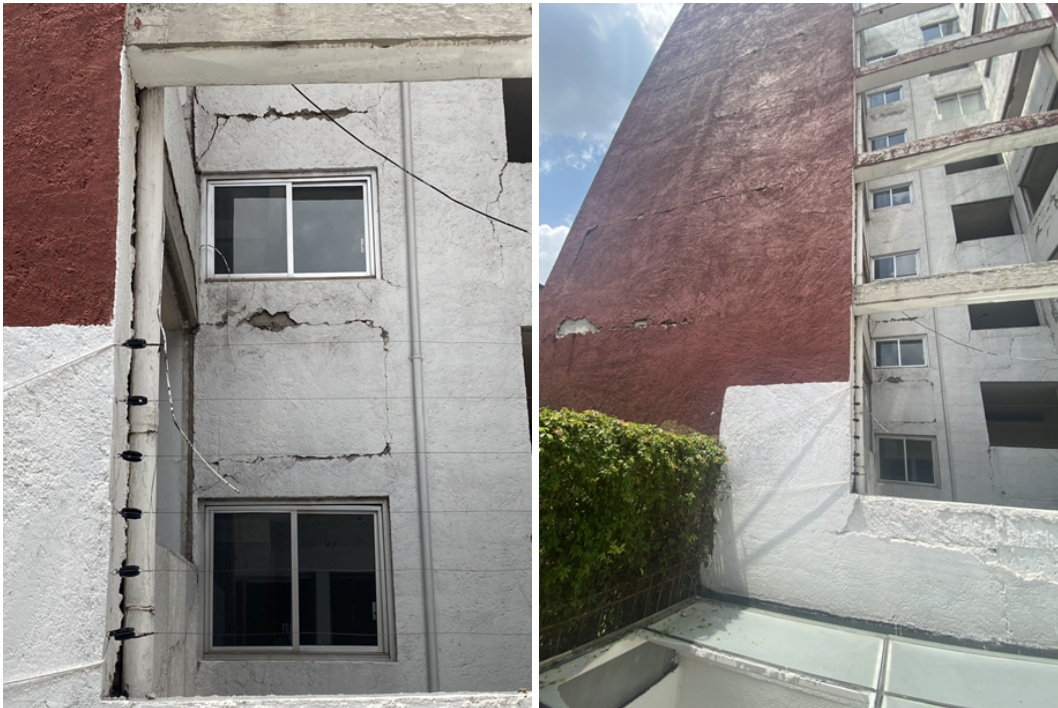
**Figure 8.13. Building located at Canal de Churubusco # 351 with some cracks and damage in the facade (Twitter, 2022v).**

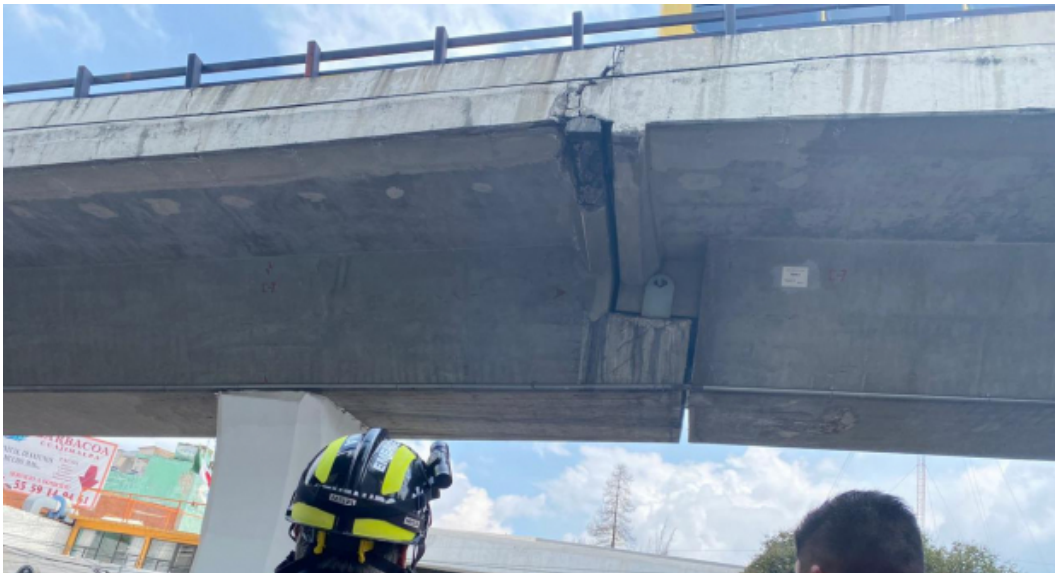
**Figure 8.17. Bridge at Palma Criolla, Huixquilucan, State of Mexico, closed to traffic after the earthquake. (La Razón, 2022a).**

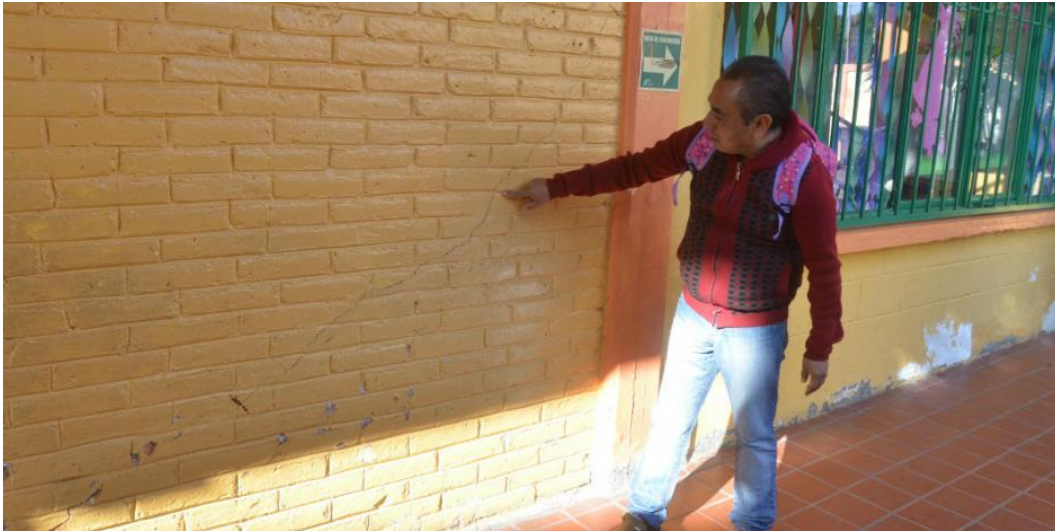
**Figure 8.18. Diagonal cracking in masonry infill wall in a school. (La Razón, 2022b)**

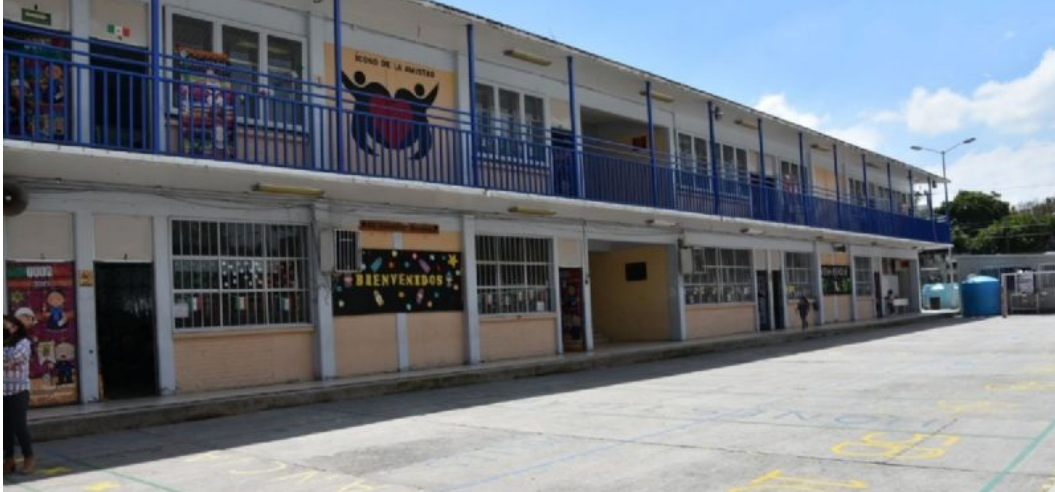
**Figure 8.19. Albino García school in Mexico City with nonstructural damage in window framing (Proceso, 2022b)**
