**REPUBLIC OF CYPRUS
MARINE ACCIDENT AND INCIDENT
INVESTIGATION COMMITTEE**

**Investigation Report 49E/2022
Very Serious Marine Casualty
Fatal Accident onboard “SAIPEM FDS” on 02 April 2022
at Limassol Roads**

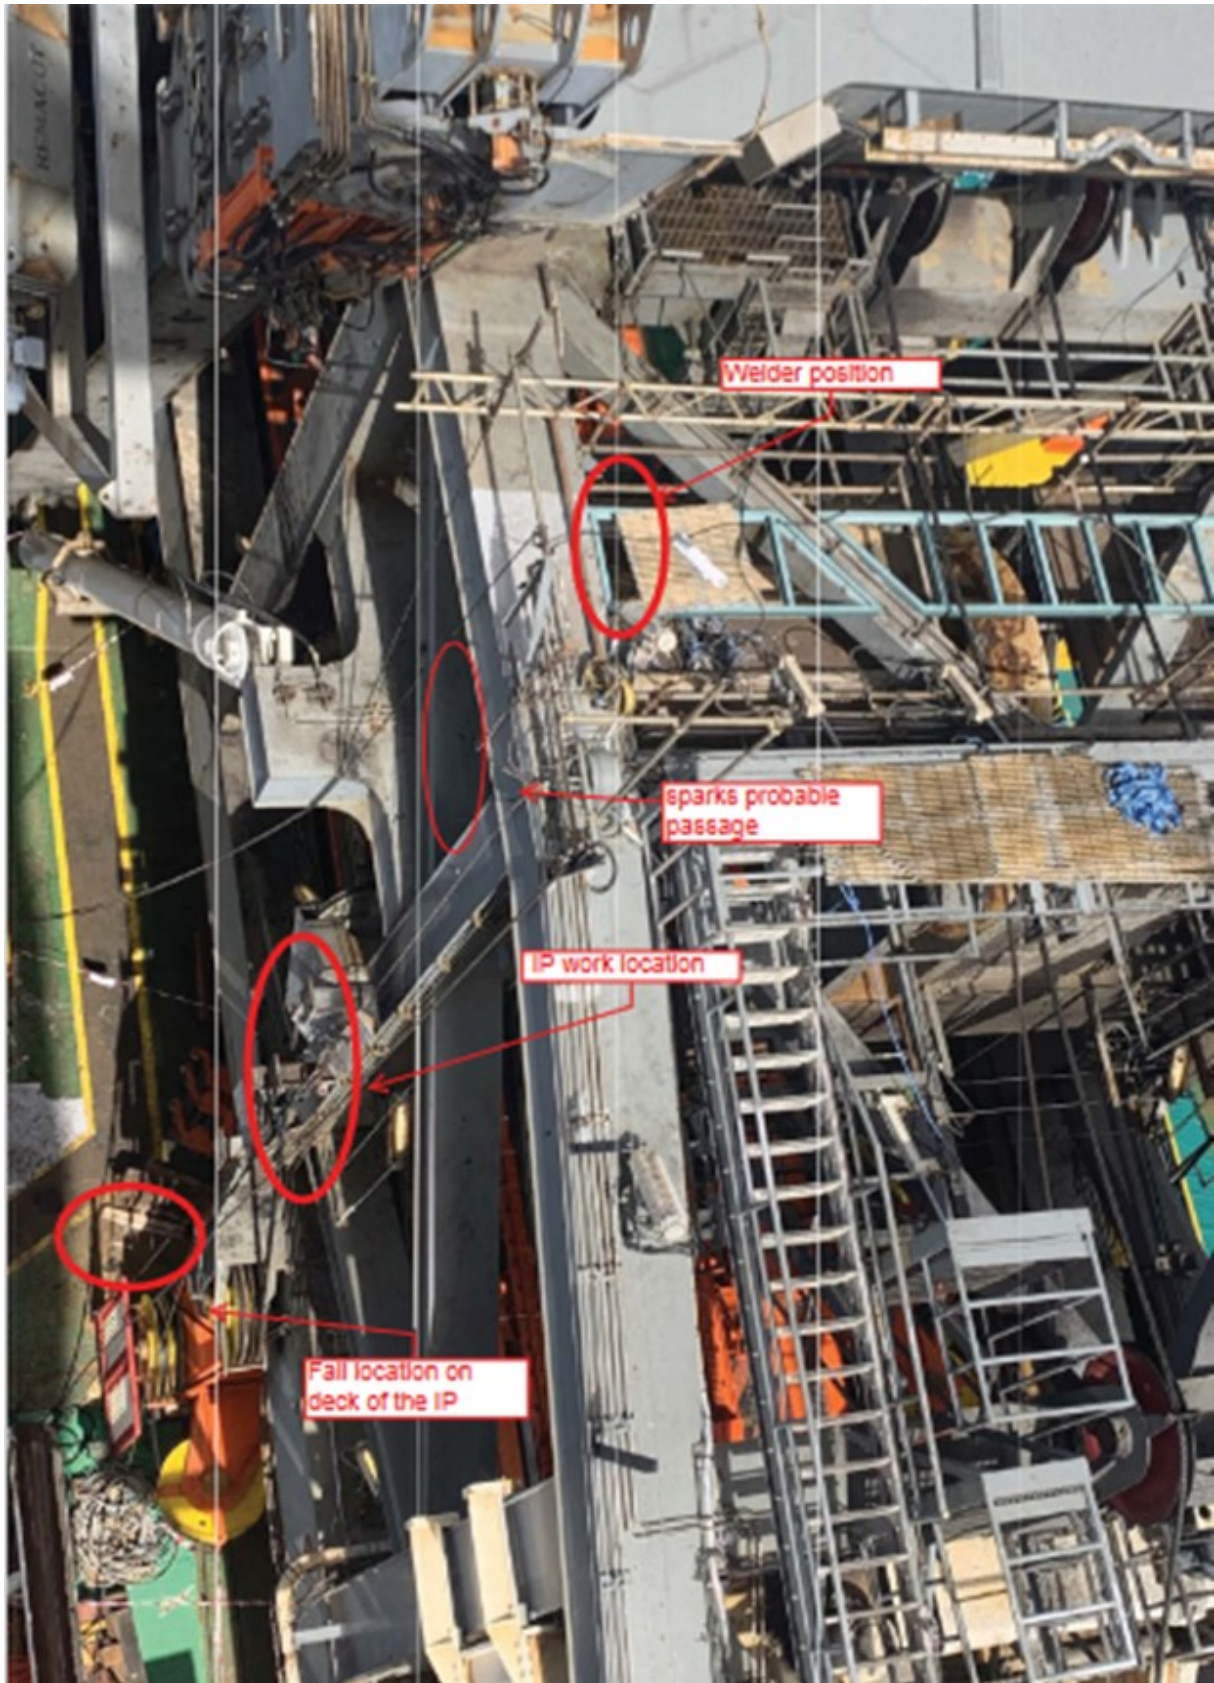
16. The Second Assistant Supervisor stated that at 16:10 Hrs ST, while he was on top of the main crane, he observed the IP working.
17. At about 16:15 Hrs ST, sparks emanating from the welding operation area, fell into the thinner can hanging to the side of the IP and ignited. After the thinner can caught fire, the IP panicked and tried to get rid of it by pushing the can away. The can came back and as a result, the thinner splashed and the flame spread onto him. The fire burned the safety harness and the rope securing it, causing him to fall down to the main deck. After falling on the main deck, he continued to burn.

The possible route followed by the sparks.

Sparks generated during welding activities were not contained and fell down to the area where "Top Rope" subcontractor workers, were working, caused the ignition of the liquid contained in the can hanging next to the victim and subsequent fatality.

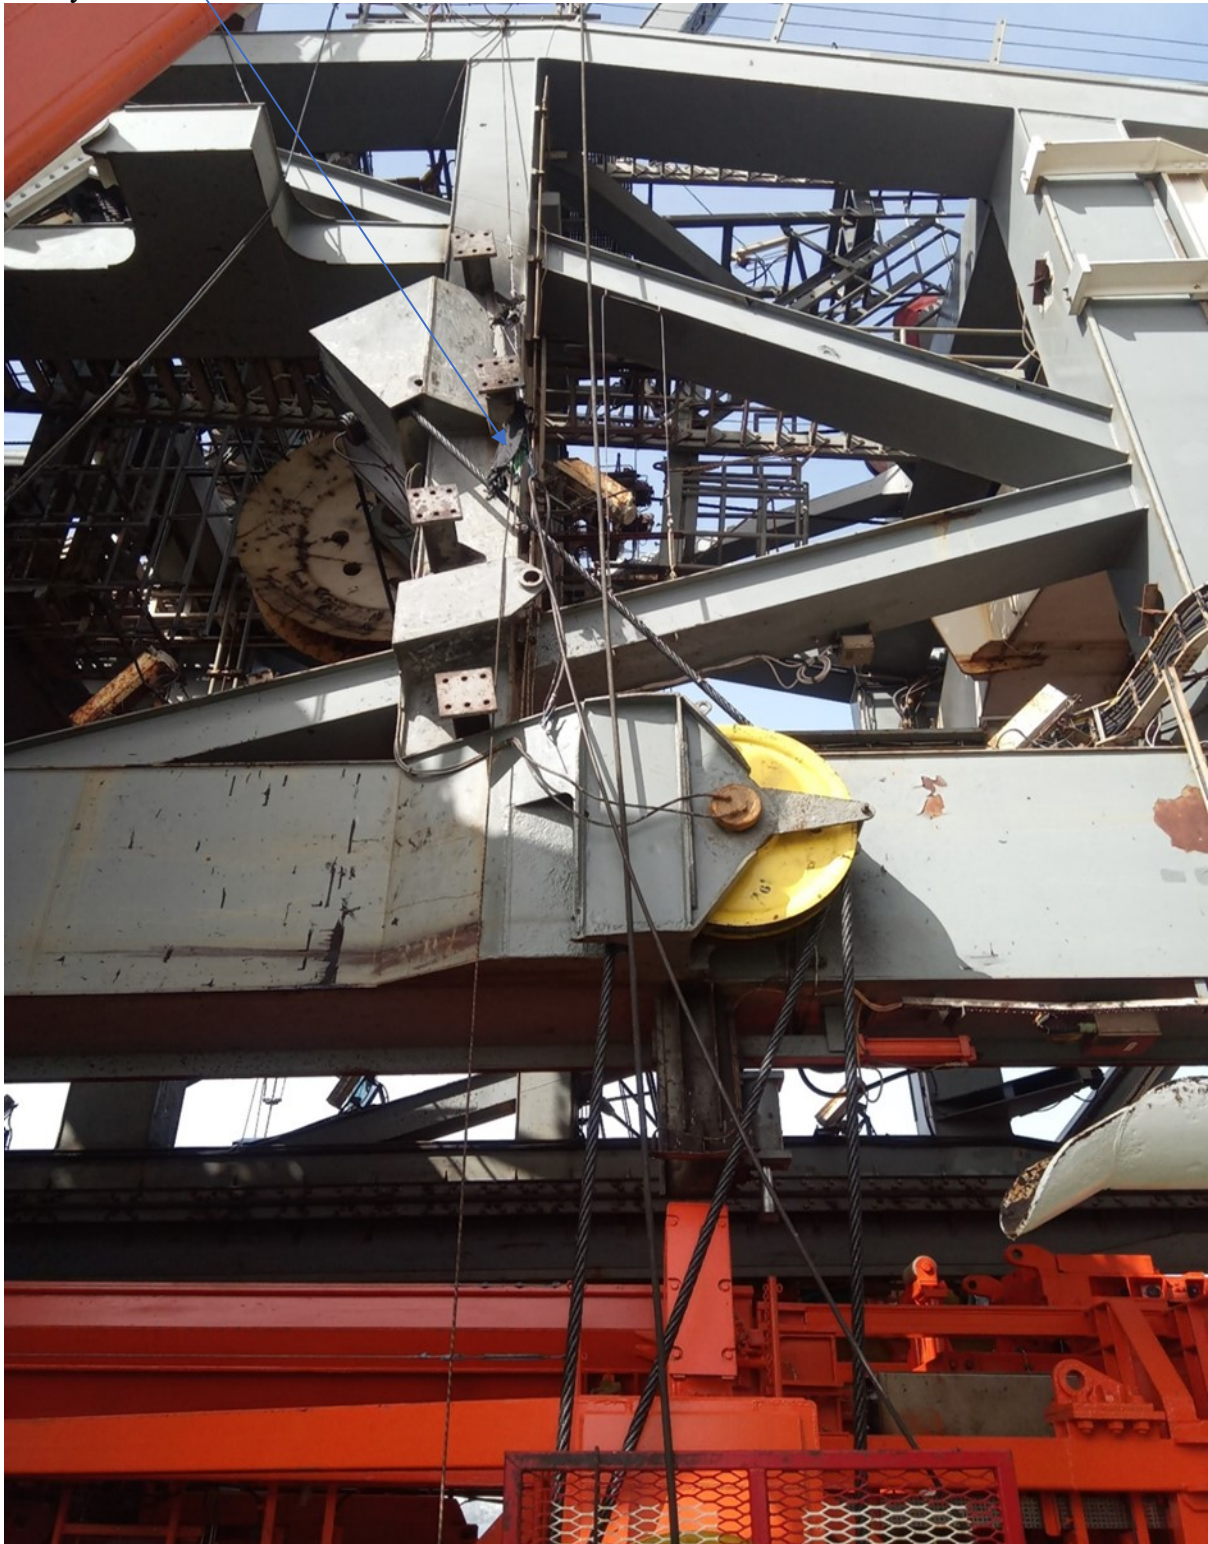
Safety Harness remains

Nevertheless, sparks from the welders fell into the can with thinner, which caught fire. The “Top Rope” worker tried to get rid of the can by pushing it, but by doing so the thinner splashed on his body. He was suddenly completely ablaze, the rope and safety harness burnt and he fell down to the main deck.

A burnt safety harness can be seen which remained stuck.
