Royal Mail Fleet

TECHNICAL SERVICE BULLETIN

TSB Number:	26/17	Enquiries to:	Nigel Lawson 07711 095404	Page:	1 of 2
Issue Date:	Dec 2017	Must complete by:	N/A	<div>BUFF</div>	
Make:	Peugeot	Model:	Expert 66 plate >		
Serial No:	6980176 >				
VIN:	N/A				
Action:	CASCADE INFORMATION TO TEAM				
Subject:	Load Area and Cab Locking

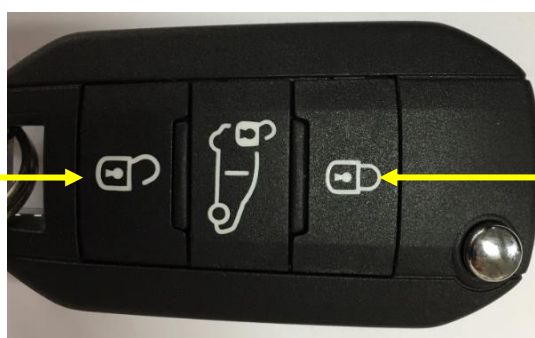
Cab Doors
Unlock Button

Door Lock
Button

Firstly check if the locking system is working correctly by locking the vehicle, then press the cab unlock button on the key fob. If the load area can be opened the locking system requires resetting. The system can be easily returned to the Royal Mail Fleet locking option by carrying out the procedure shown in the image on page two of this TSB. The instructions can also be found on page 39 of the vehicle manual.
