Environmental Monitoring Report

Reporting Period
02/08/2010-29/08/2010
Revision1.

Former Bayer Crop Science Site
Hauxton
Cambridgeshire

15th September 2010

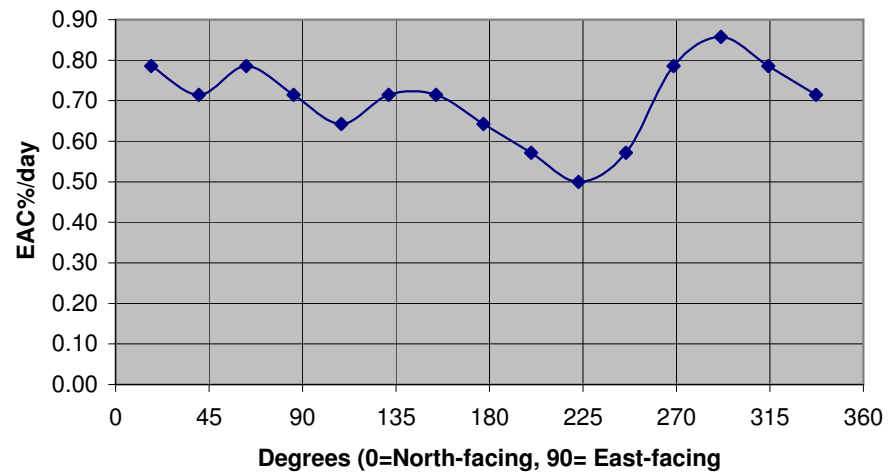
EAC%/day vs Orientation

Note: Cells coloured yellow are inputs.
 The rest are either constants or calculated values.
 The calculation is based on taking readings at 40mm intervals along the sticky pad.
