# Environmental Monitoring Report

01/11/2010-28/11/2010

Former Bayer Crop Science Site  
Hauxton  
Cambridgeshire

10<sup>th</sup> December 2010

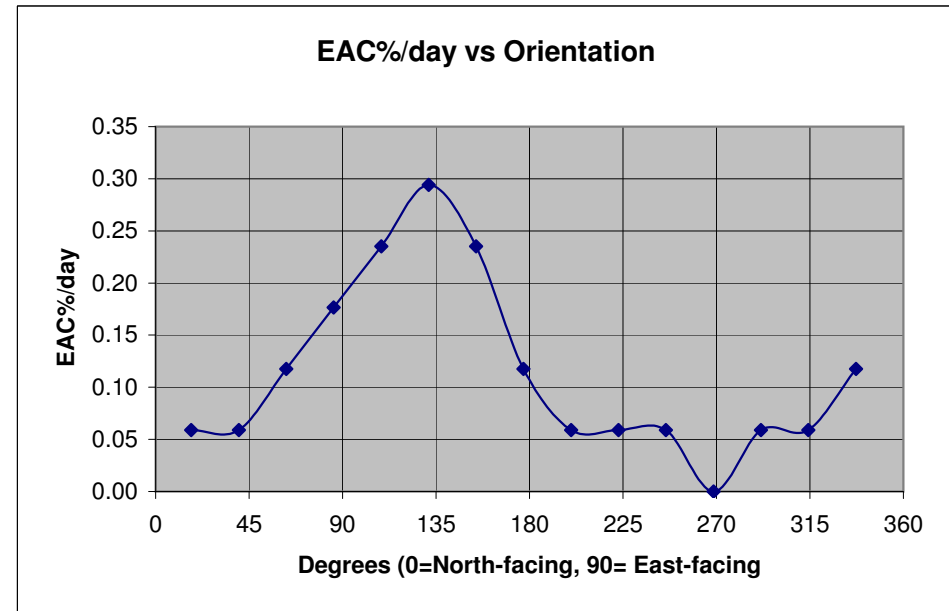
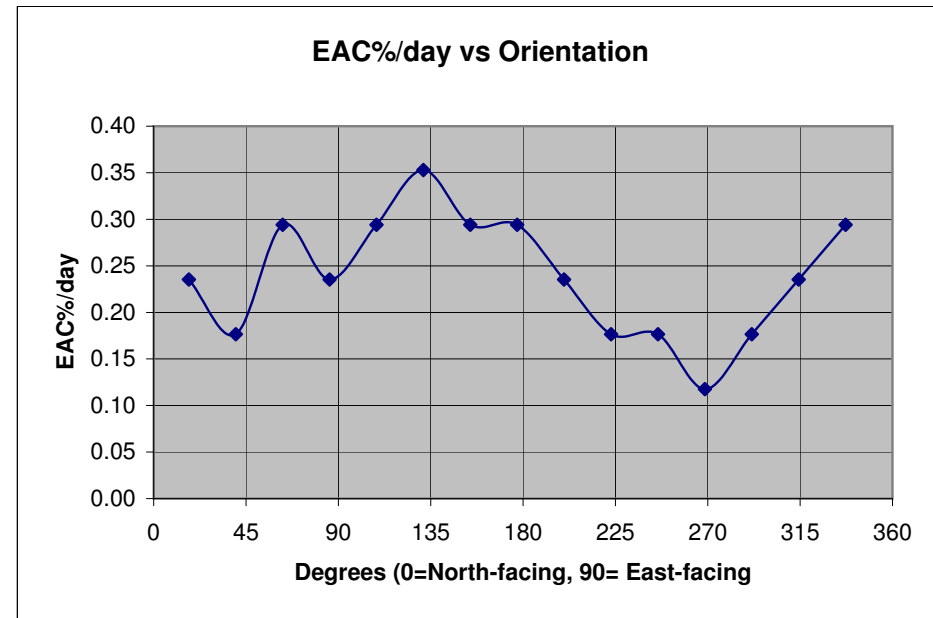
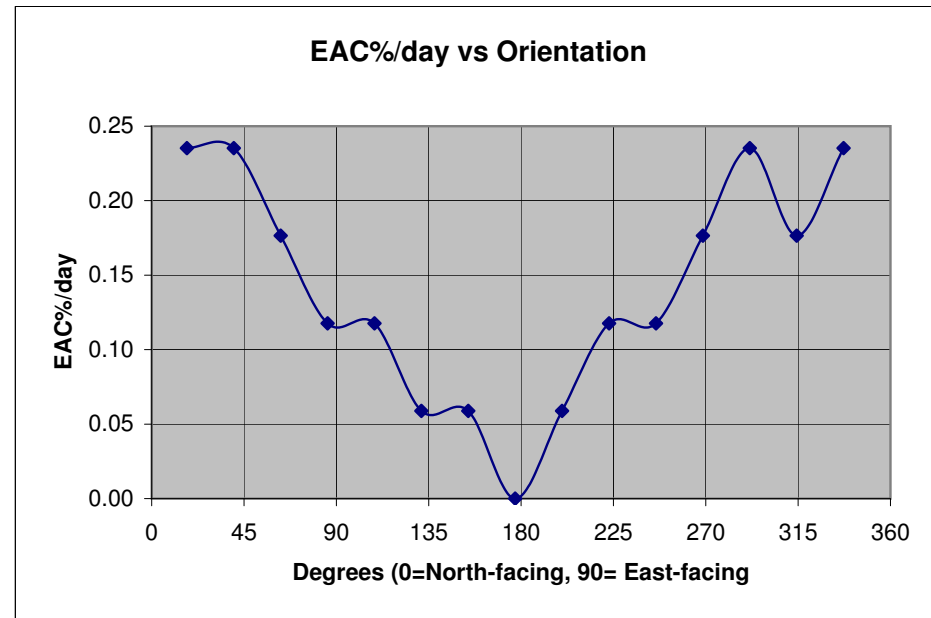
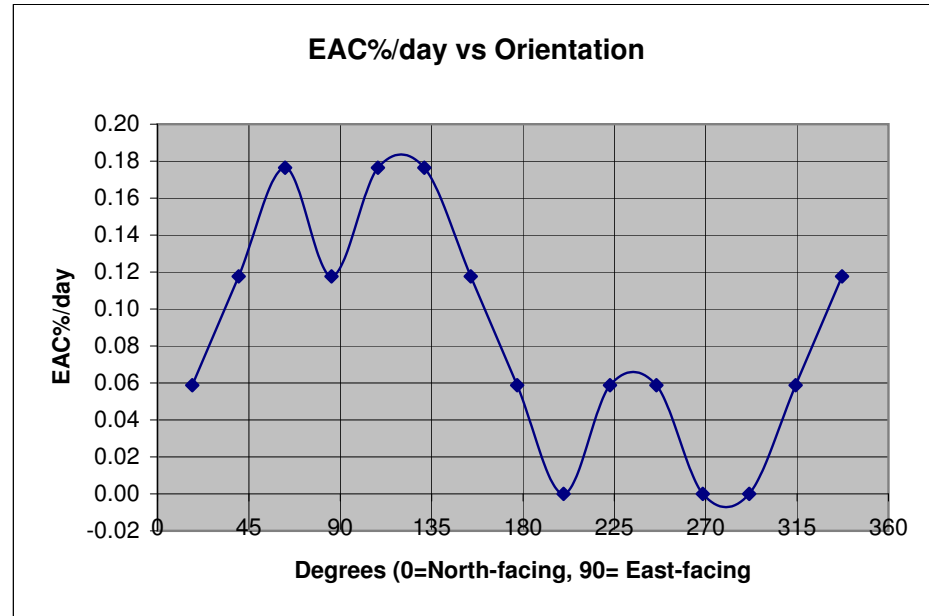
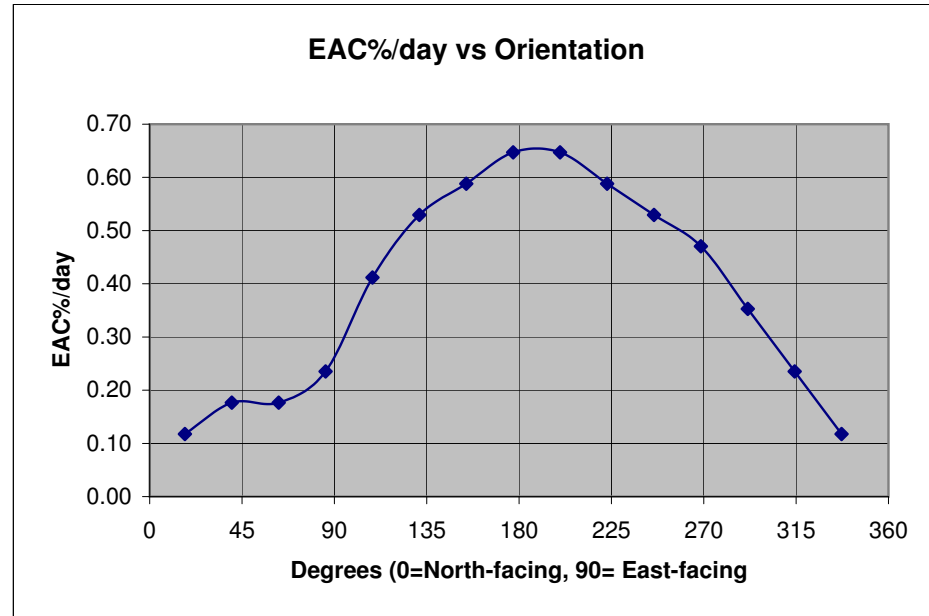
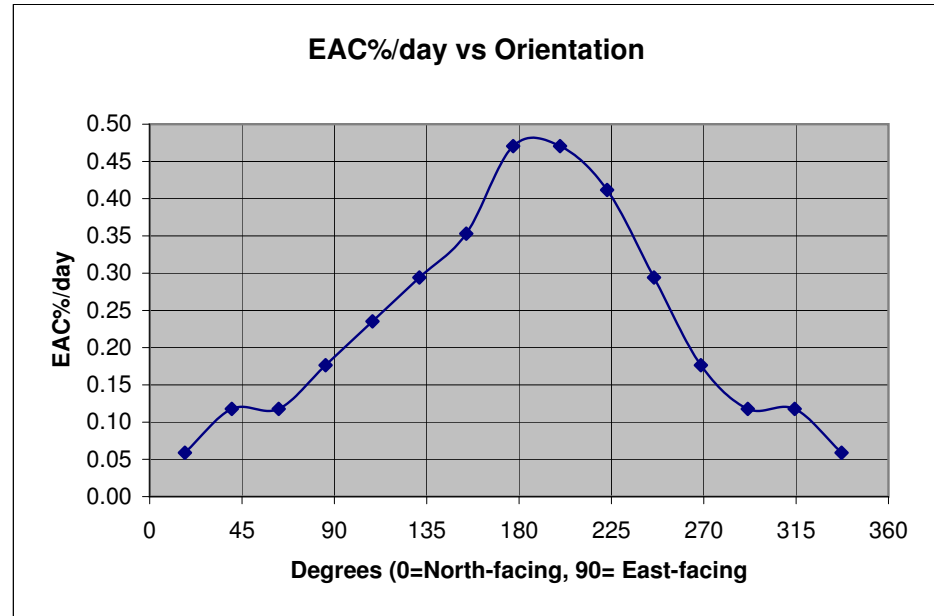
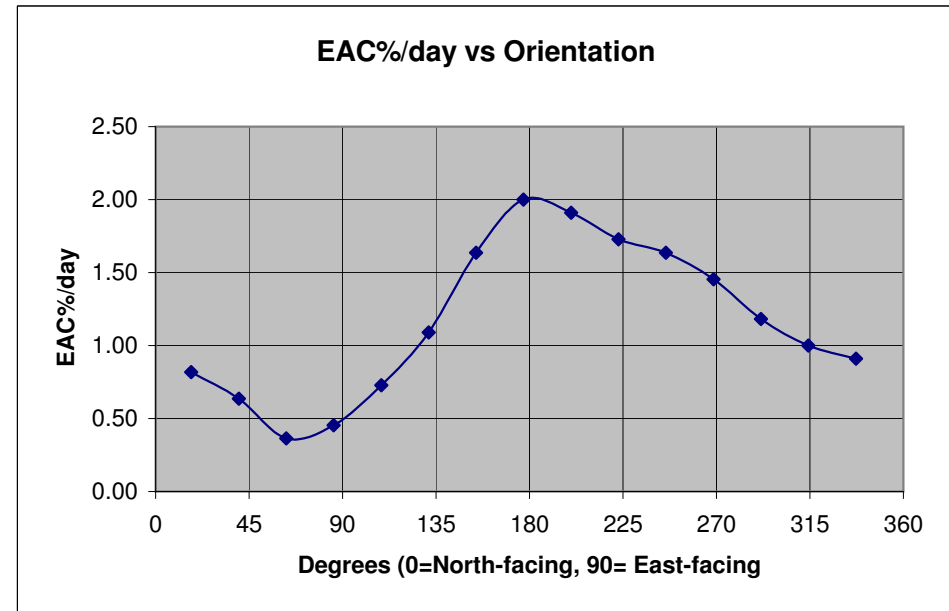
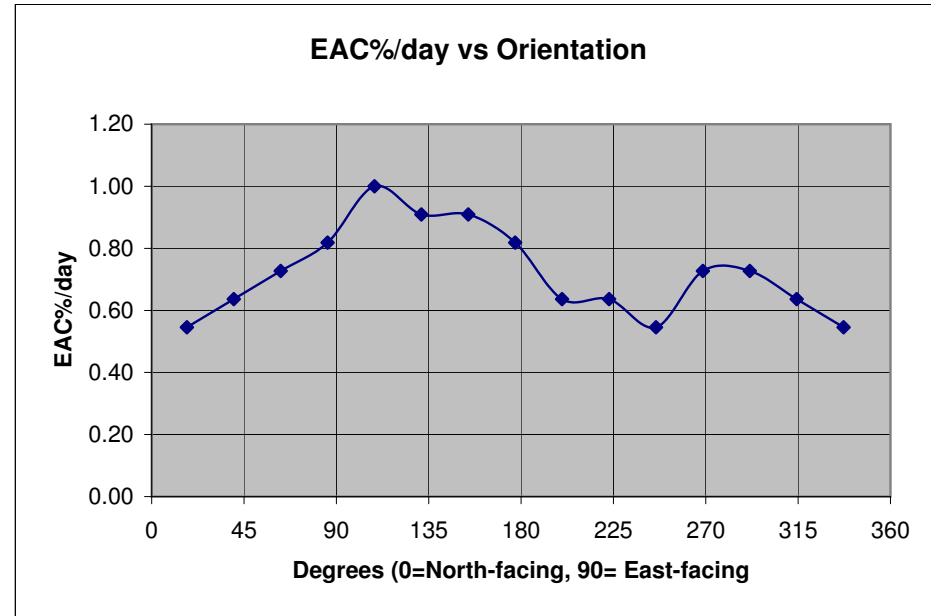
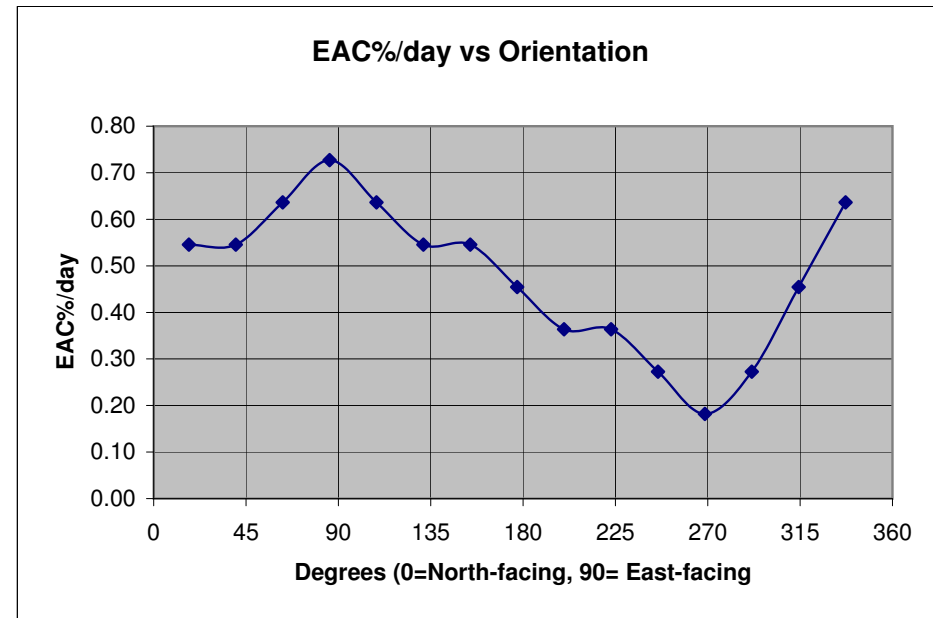
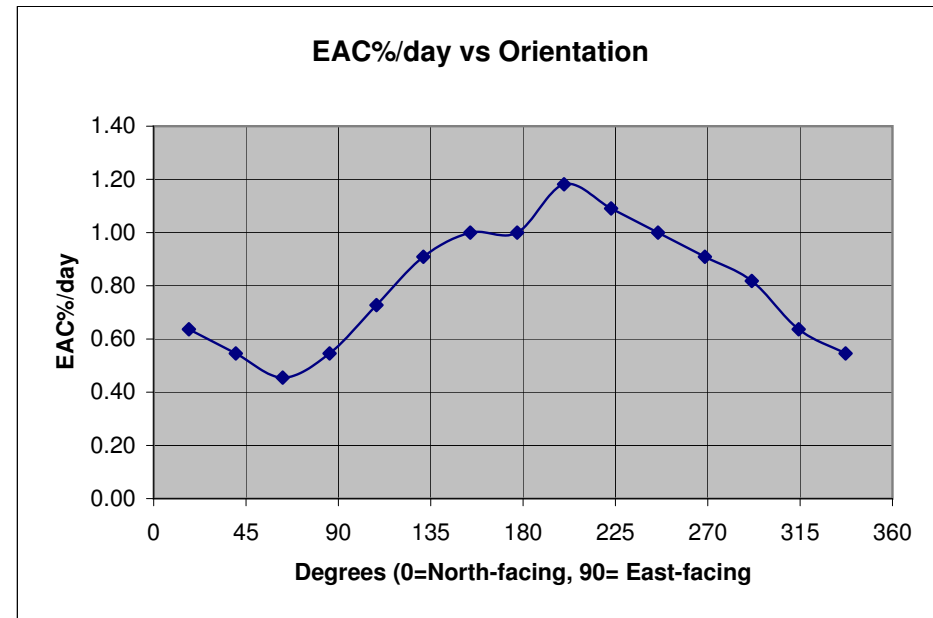
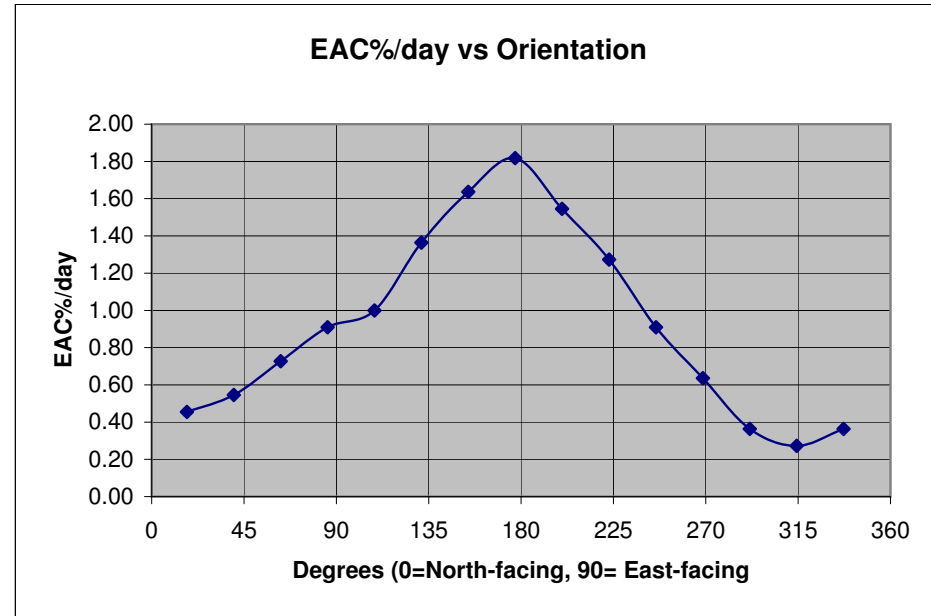
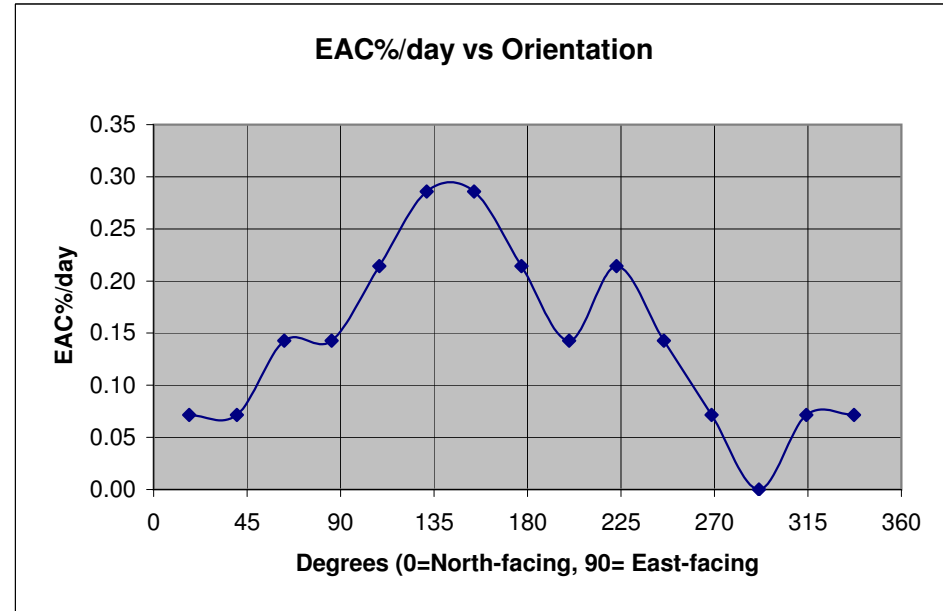
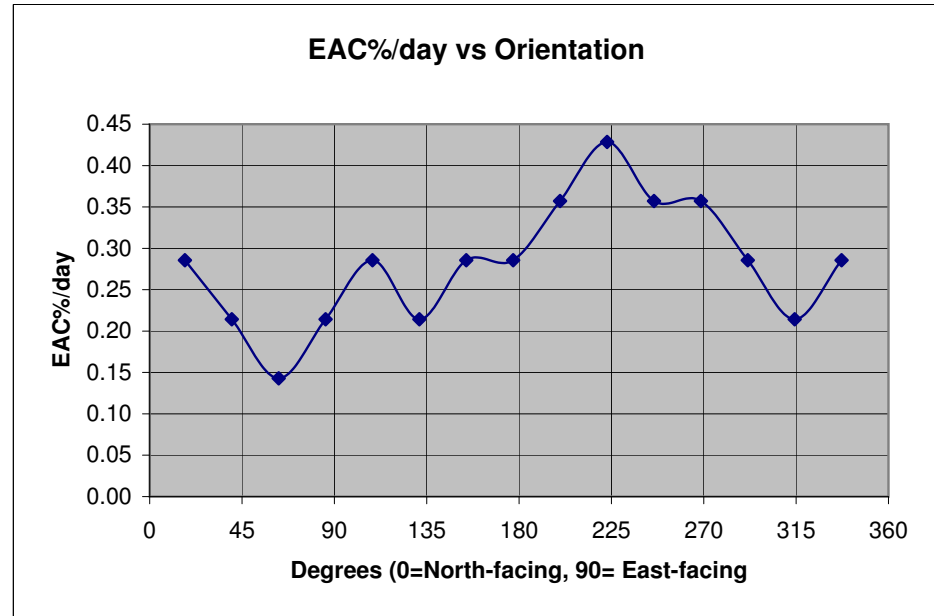
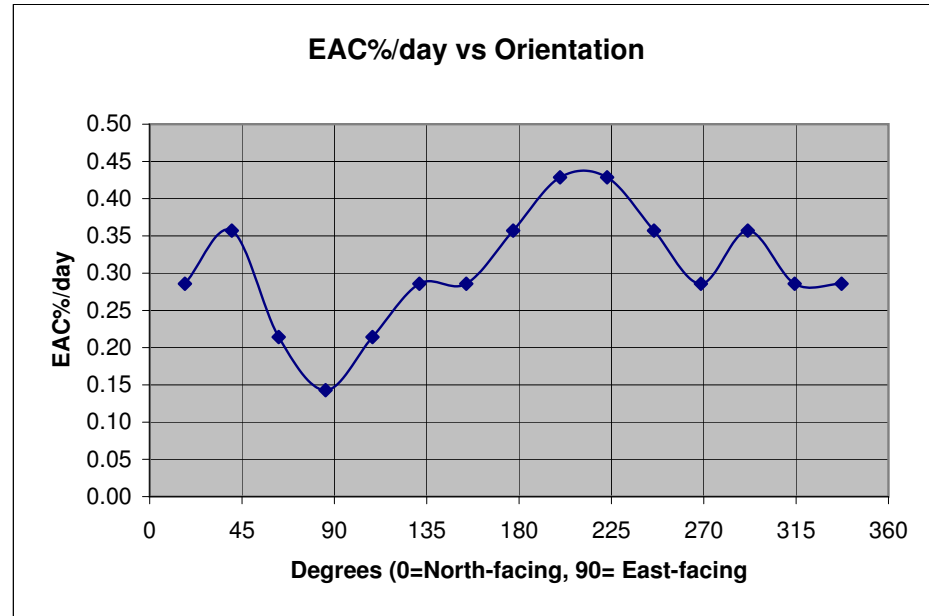
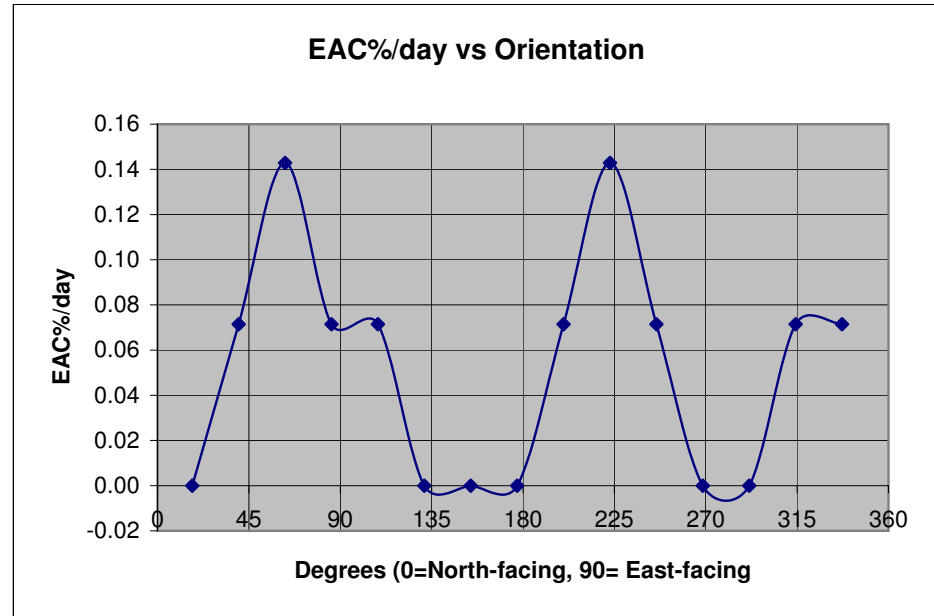
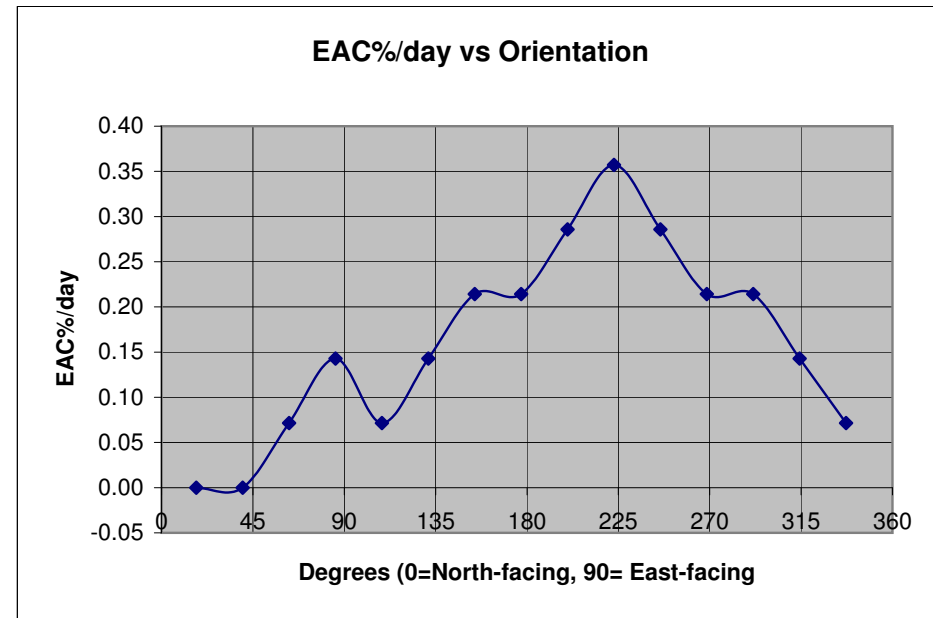
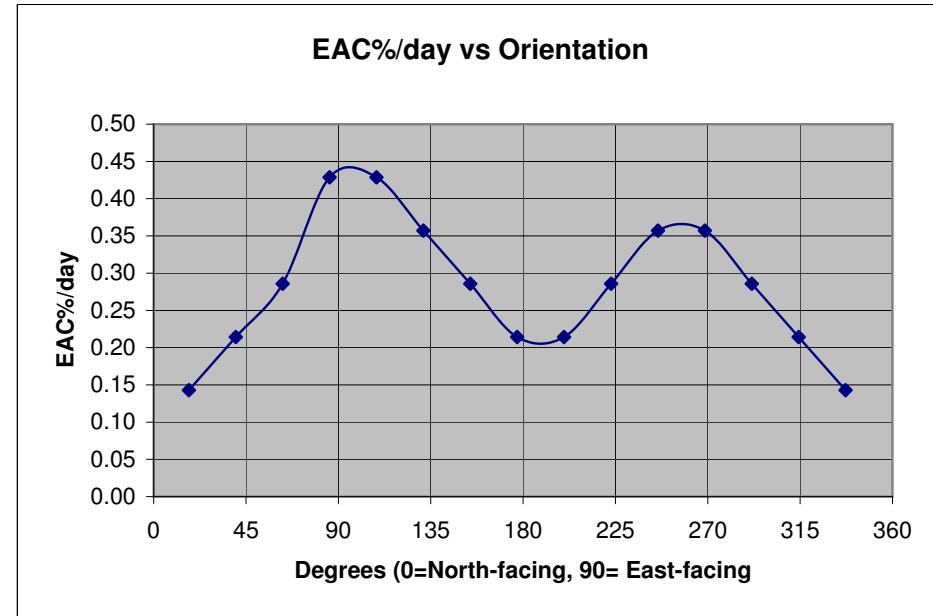
Directional dust deposition gauges at the six monitoring locations are analysed every fortnight for Effective Area Coverage (EAC) (percentage of dust deposition relating to the potential to cause nuisance), results generated by an external laboratory are presented in Appendix D.

Dust deposition values of less than 2.5% are regarded as having a very low nuisance potential. Only when percentages rise from 2.5% – 5% EAC is dust considered to have a low nuisance causing potential. During the reported period dust, fibre and particle emissions have been low, and have not caused visual dusting off site.

Note: Cells coloured yellow are inputs.  
The rest are either constants or calculated values.  
The calculation is based on taking readings at 40mm intervals along the sticky pad.
