## AQUILA, MICHOACÁN, MEXICO SEPTEMBER 19, 2022, $M_w$ 7.6 EARTHQUAKE

### PRELIMINARY VIRTUAL RECONNAISSANCE REPORT (PVRR)

Virtual Earthquake Reconnaissance Team (VERT) Lead:  
Eduardo Miranda, Stanford University

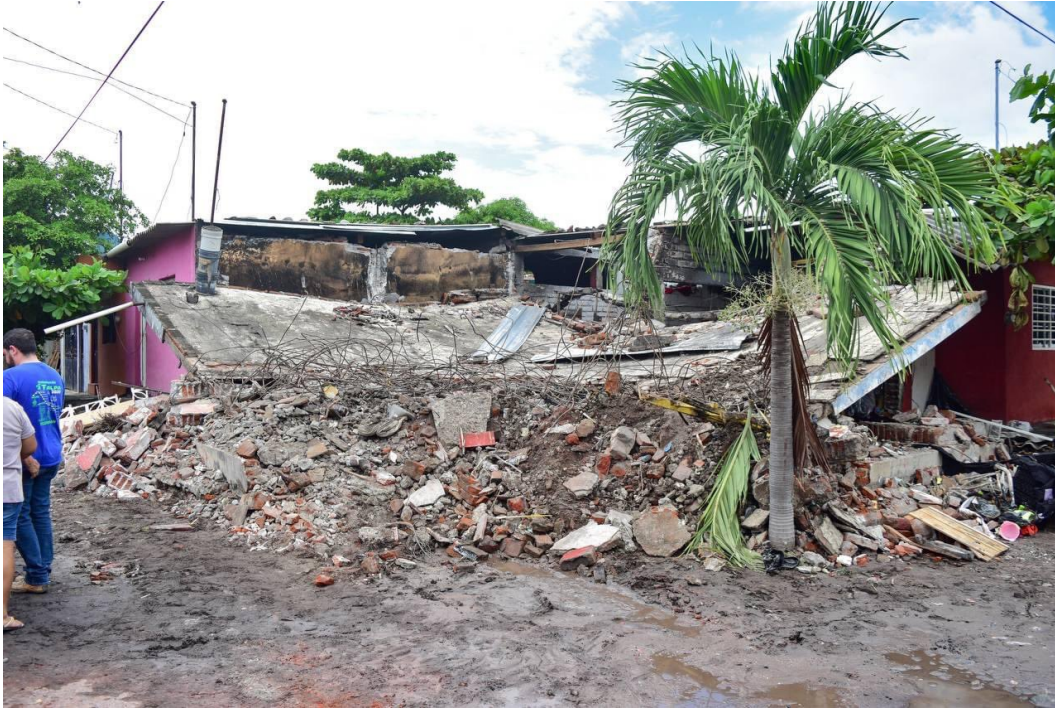
The images of collapsed residential buildings (Figure 7.1 - Figure 7.3) show vulnerable unreinforced masonry (URM) structures, which are known to have low in-plane and out-of-plane displacement capacity. There were also cases of severe URM damage in the form of shear failure of short piers due to the low in-plane masonry strength (Figure 7.4), collapsed roofs (Figure 7.5), and cracked walls (Figure 7.6). Reinforced concrete building collapses also occurred possibly due to system irregularities and non-ductile concrete characteristics (Figure 7.7 and Figure 7.8). Intact columns are observed in Figure 7.7, indicating potential failure of beam-column joints, leading to collapse.

**Figure 7.2. URM single-family house completely collapsed in Coalcoman, Colima (PBS, 2022).**

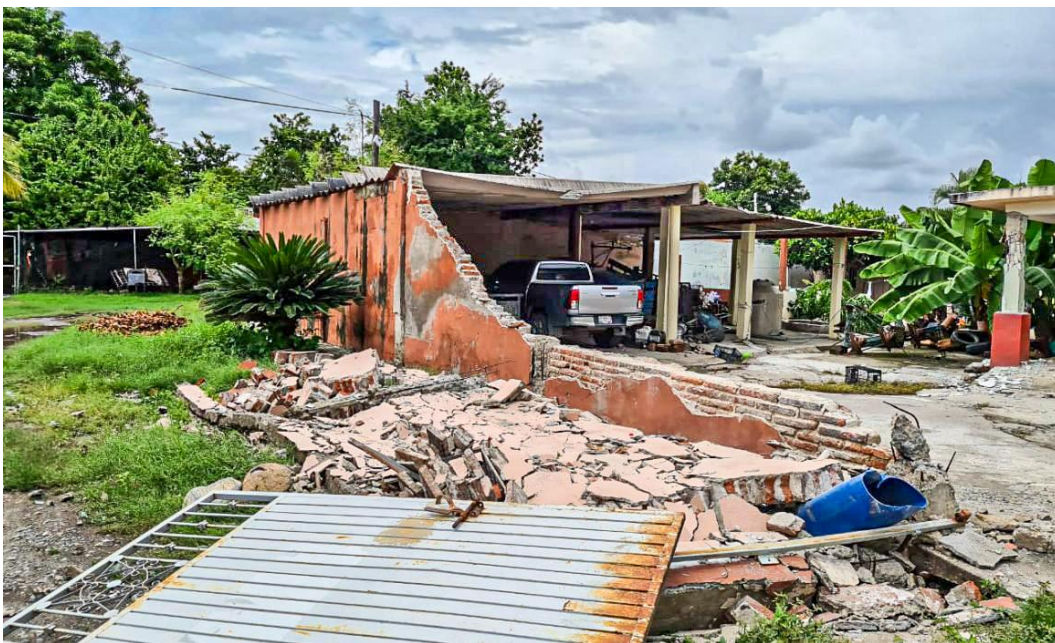
**Figure 7.3. Collapsed URM wall in single-family buildings in Morelia, Michoacán (Quadratin, 2022b).**

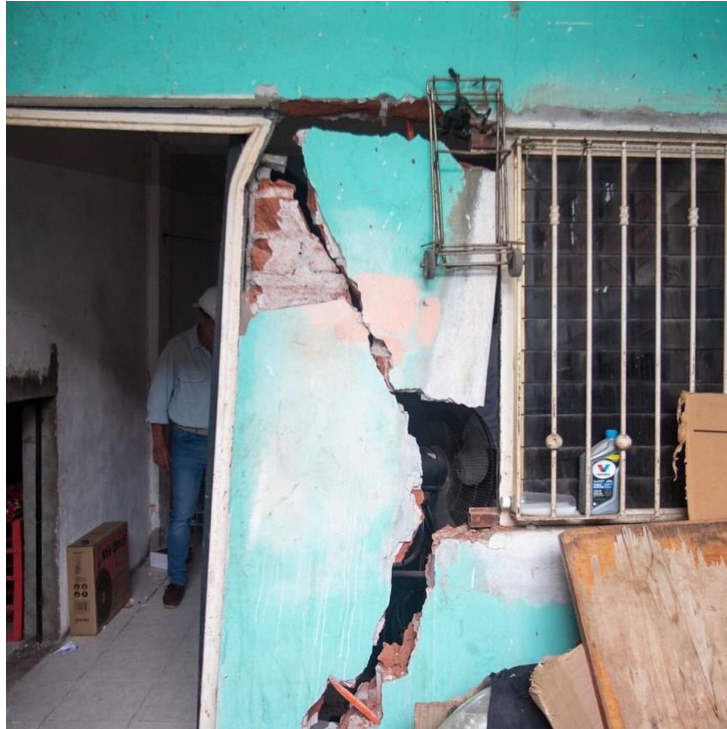
**Figure 7.4. Collapsed URM wall in single-family house in Tecomán, Colima (Twitter, 2022f).**

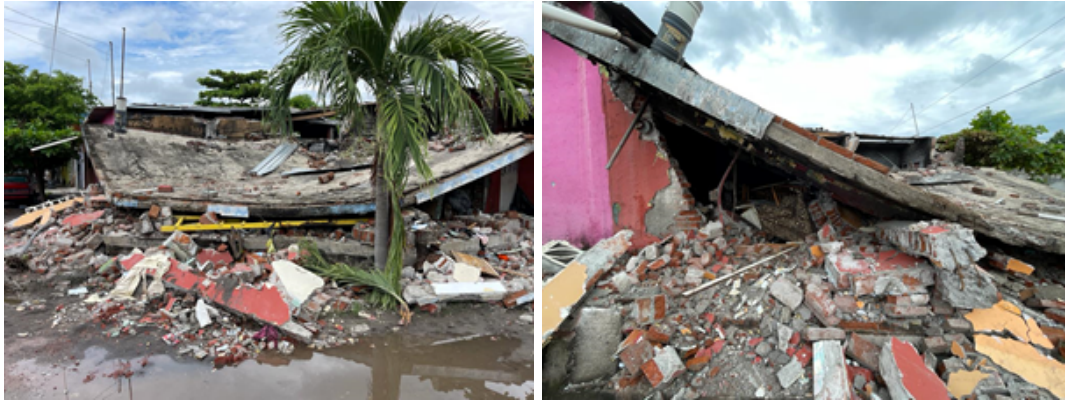
**Figure 7.8. Total collapse of a reinforced concrete single-family building with masonry infill walls in San Isidro, Tecomán, Colima (Facebook 2022d)**

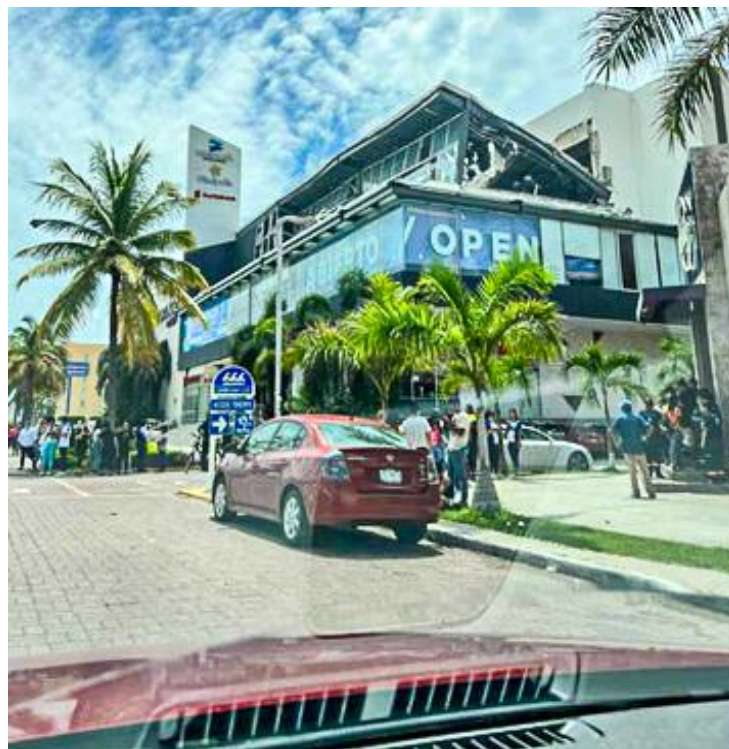
Many commercial buildings experienced damage. The collapsed roof at Plaza Punto Bahia is one of the most relevant as it caused the death of one occupant. According to the pictures in Figure 7.11 to Figure 7.13, the steel structure seems to have failed when the beams detached from the concrete structure during the earthquake (Figure 7.11). The other case which also resulted in a fatality was the out-of-plane partial collapse of the facade of the Valle de Garzas store as shown in Figure 7.14 to Figure 7.16. It is likely that the heavy masonry sections that fell were not effectively anchored to the main structure.

Figure 7.12. Collapsed roof in Plaza Punto Bahía in Manzanillo, Colima (Twitter, 2022e)

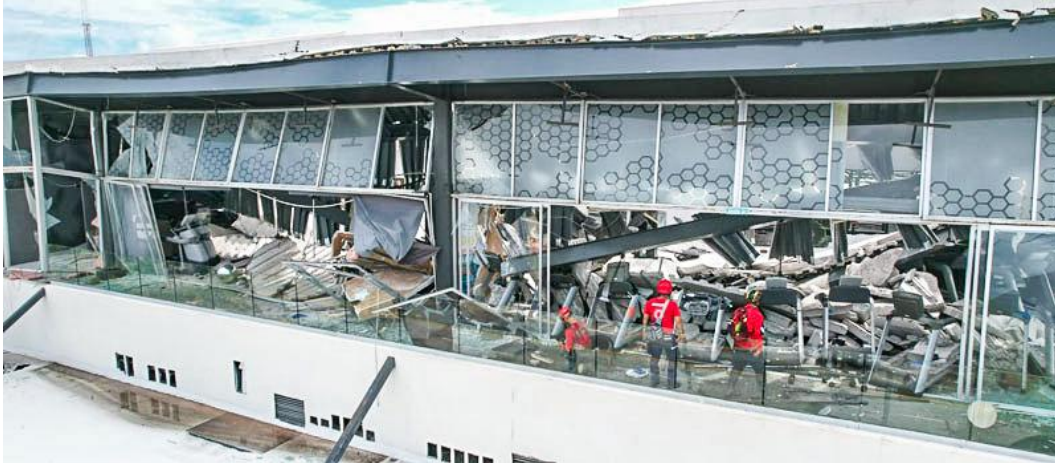
**Figure 7.13. Collapsed roof in Plaza Punto Bahía in Manzanillo, Colima (Diario de Colima, 2022a)**

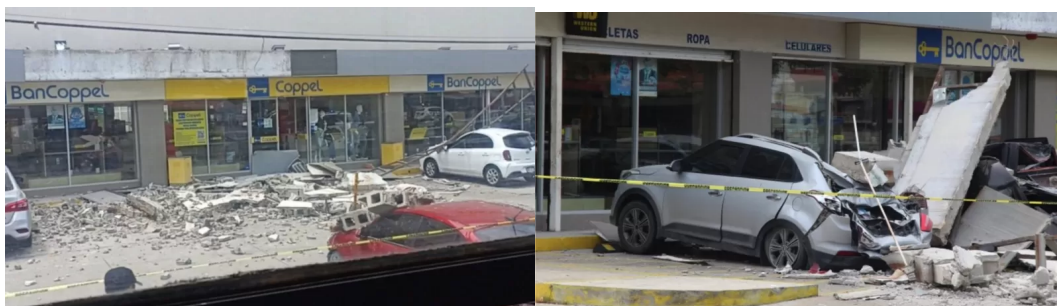
**Figure 7.16. Out-of-plane wall failure in the Coppel store at Valle de las Garzas in Manzanillo, Colima (BBC, 2022).**

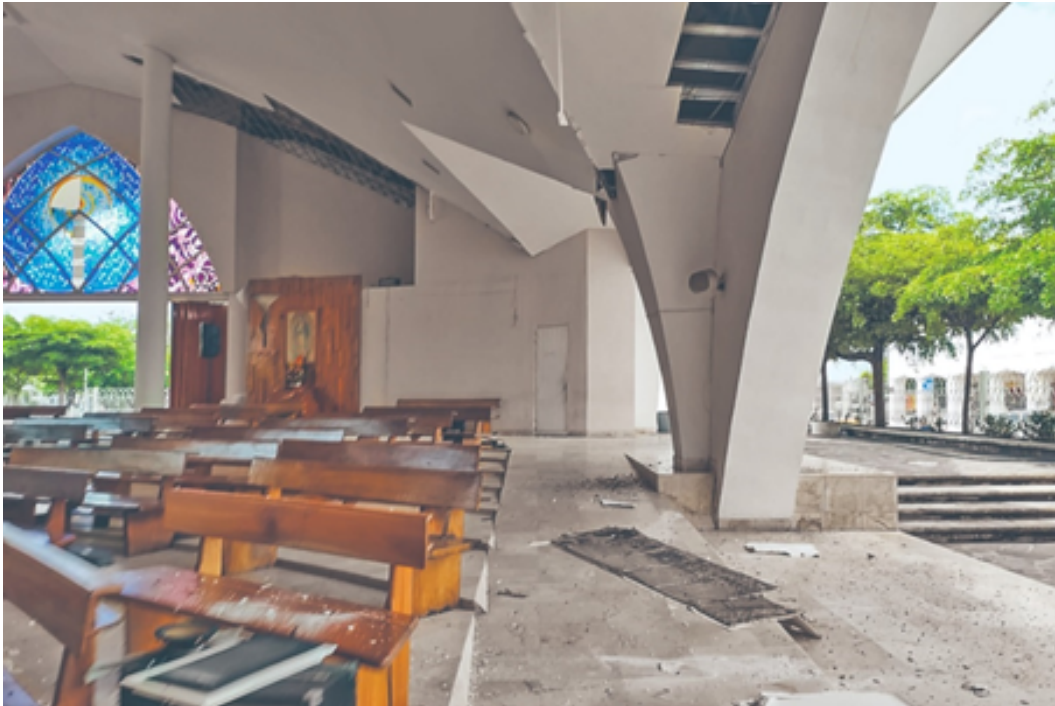
According to National Coordination of Civil Protection in the state of Colima, two churches suffered severe damage (Twitter, 2022a). Some examples of religious buildings that suffered damage are presented in this section. It is noted that old churches were typically built with unreinforced masonry (Figures 7.28 -7.36).

Figure 7.35. Parroquia de Santiago Apóstol in Tecomán, Colima (24 Horas, 2022).

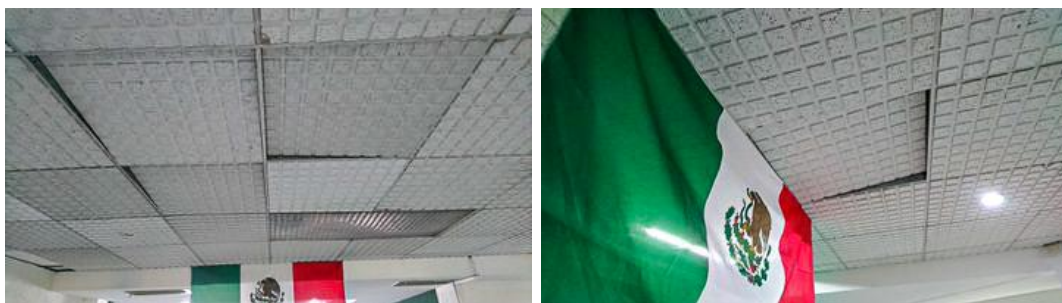
Damage to non-structural components was reported by several newspapers, news agencies and in social networks. Dislodging of ceiling tiles, as shown in Figure 7.46 and Figure 7.47, and damage to partition walls were the most common damages reported. Collapse of windows and glass facades, as the one in Figure 7.48, were also widely reported. At the public square Jardin Alvaro Obegón extensive damage to the decorative pavement was noted apparently due to the absence of a movement joint between the shore and the wharf structure (see Figure 7.49).

**Figure 7.47. Non-structural damage in Condusef Morelos office in Cuernavaca, Morelos (Twitter, 2022n).**

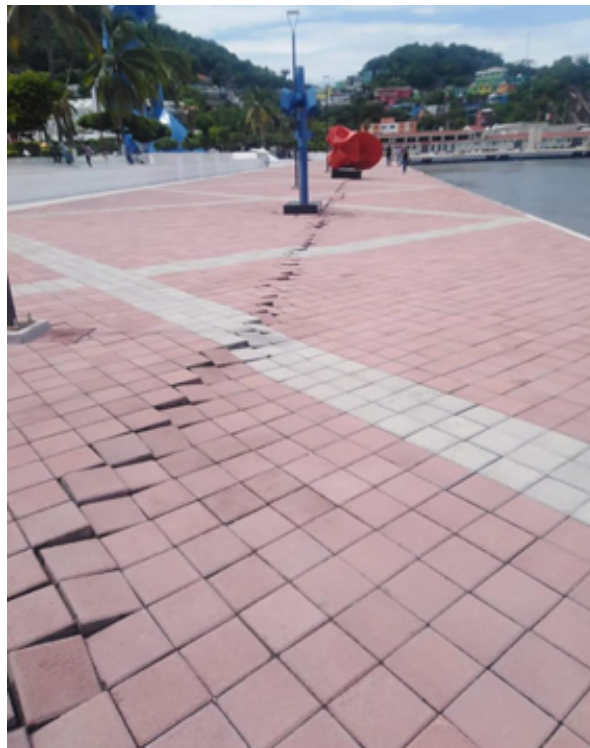
Figure 7.49. Public square Jardín Álvaro Obregón in Manzanillo, Colima (Facebook, 2022q).

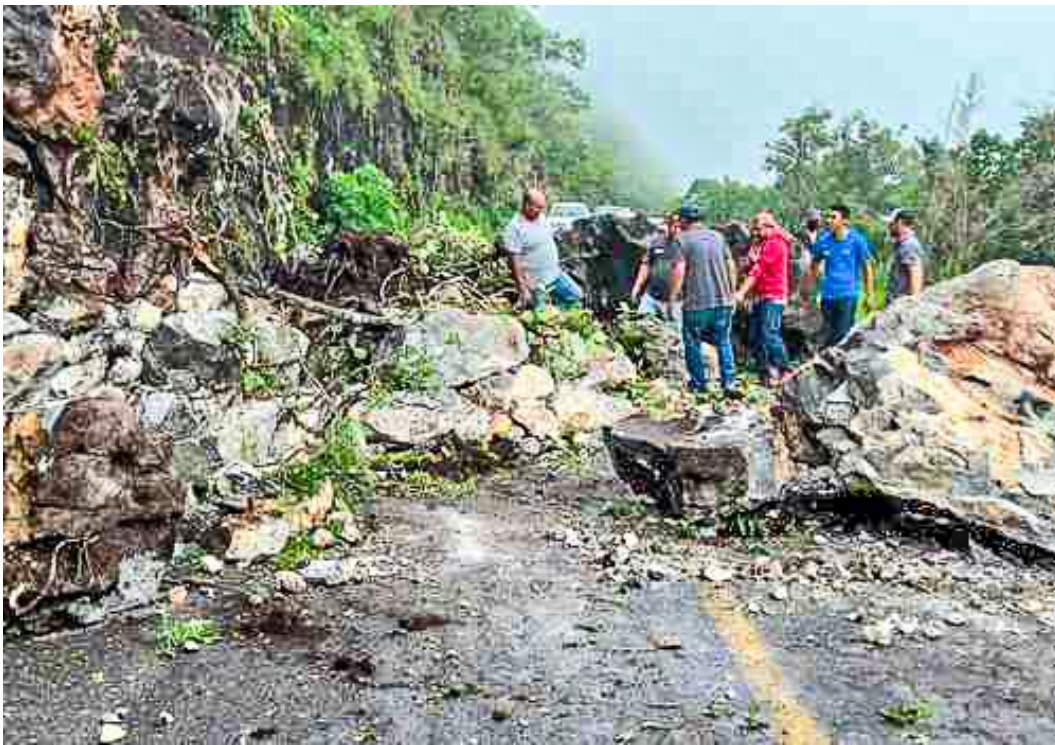
The earthquake triggered dozens of landslides and falling of large rock blocks along the entire epicentral area (Figure 7.50 and Figure 7.51). A massive landslide, shown in Figure 7.52) was reported near Colima, around 50 km from the epicenter. The Central Control, Communications, Computers, Cybersecurity and Intelligence Command (C5i) monitored several points along the roads and reported landslides as far as 70 km from the epicenter (See Figure 7.53). The USGS reports PGA values around 0.15g in this region. There were also multiple landslides along the Tecoman-Colima Federal Highway (Figure 7.54 and Figure 7.55) which is approximately 80 km from the epicenter and had PGA values around 0.1g according to the USGS.

Figure 7.50. Landslide in Coalcoman-Aquila road in Michoacán (La Jornada, 2022).

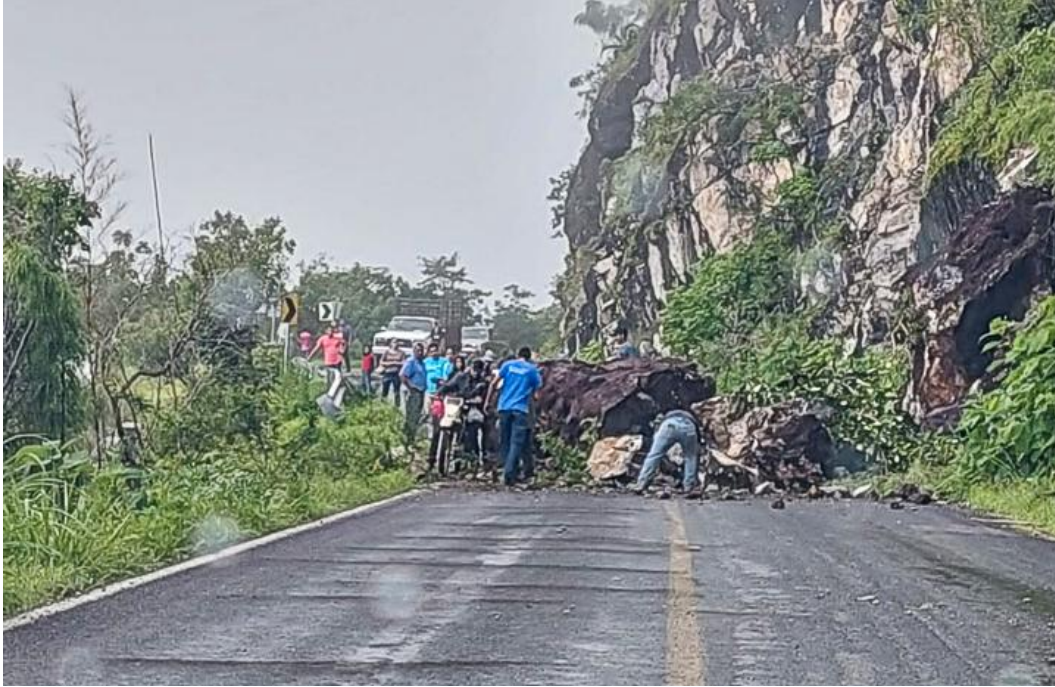
**Figure 7.51. Landslide in Coalcomán-Villa Victoria road in Michoacán (El Sol de Morelia, 2022a).**

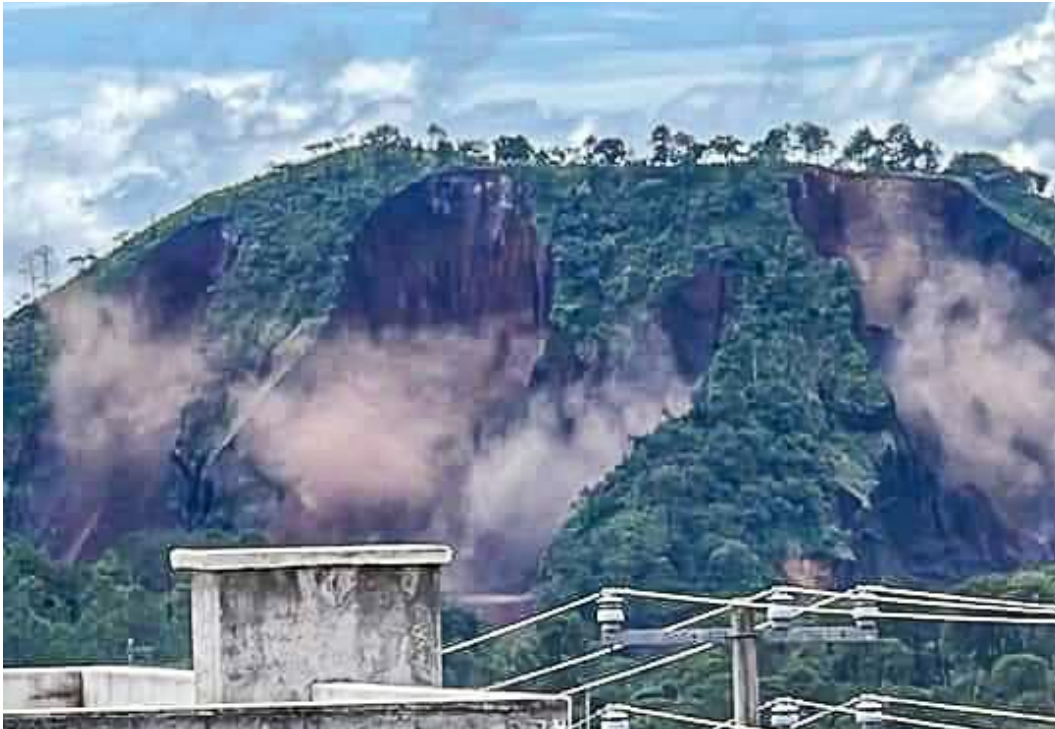
**Figure 7.52. Landslide in Colima (La Jornada, 2022).**

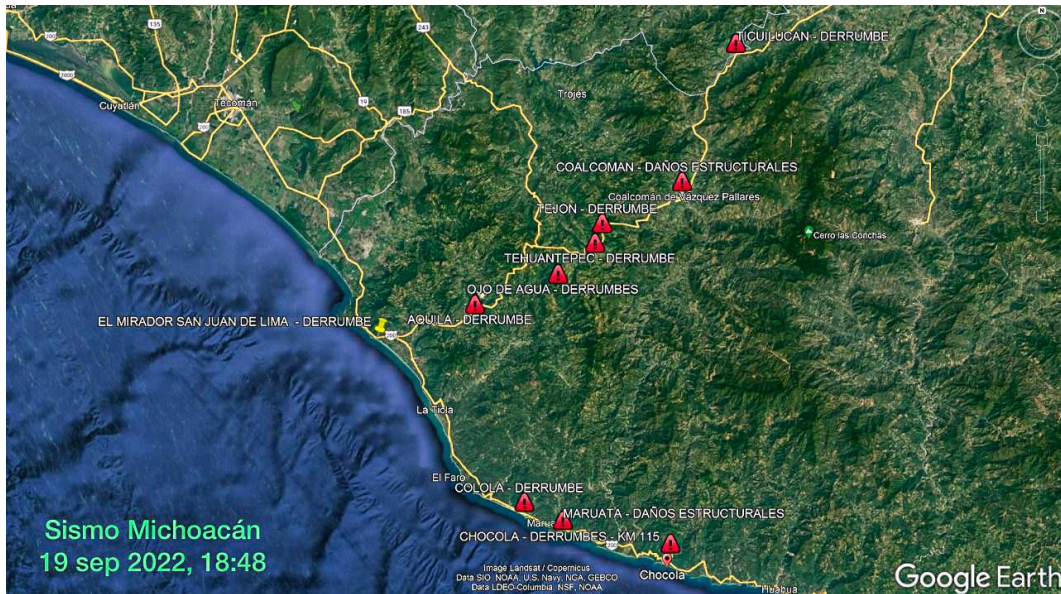
Figure 7.53. Landslides on the highway in Michoacán (Revolución 3.0, 2022).

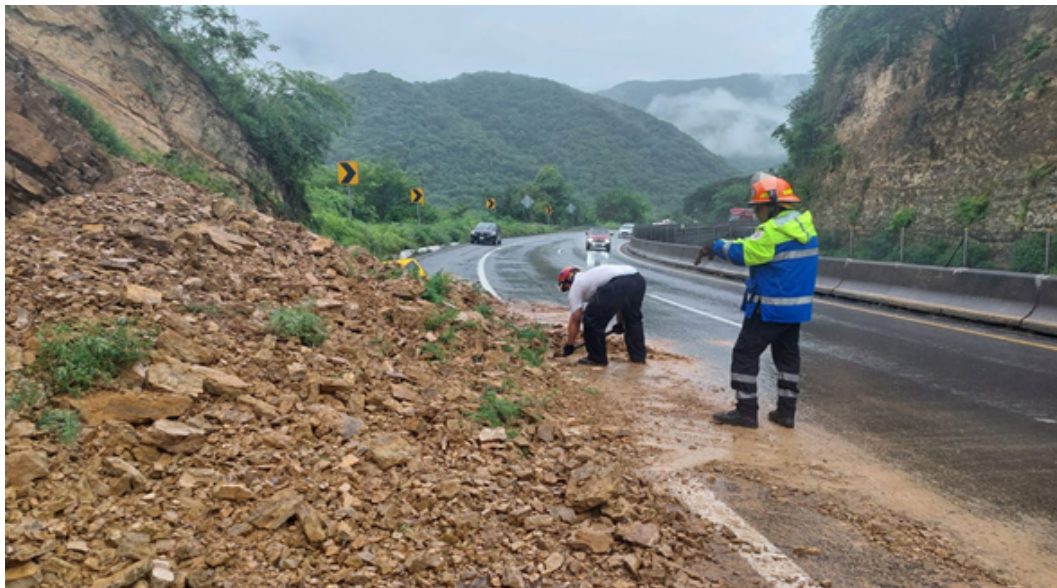
Figure 7.54. Landslide on the Tecomán-Colima Federal Highway (Uno TV, 2022)

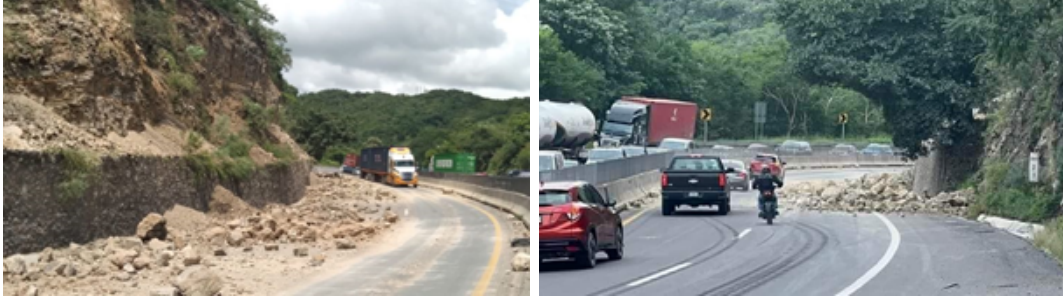
**Figure 7.55. Landslide on the Tecomán-Colima Federal Highway in La Salada, Colima: left (Sentido Común, 2022); right (Facebook, 2022r)**

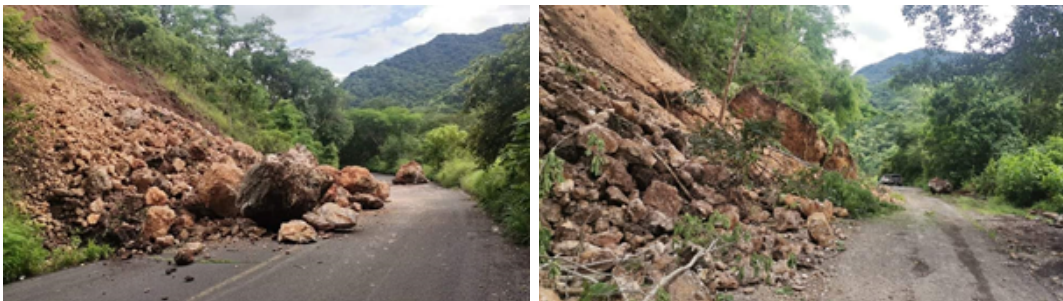
**Figure 7.56. Landslide on Villa de Álvarez-Minatitlán road in Villa de Álvarez, Colima (Facebook, 2022s)**

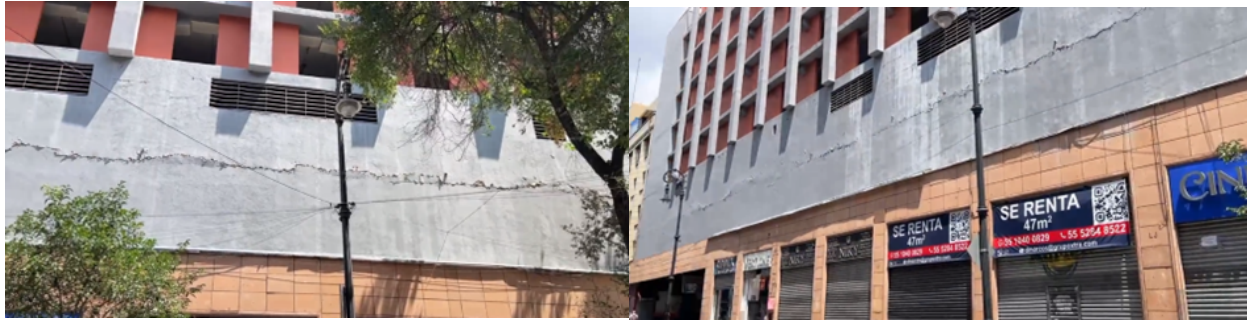
**Figure 8.2. Building located at Palma 34, in Downtown Mexico City (Twitter, 2022x).**

People reported falling debris during the earthquake at the building located in Palma 34 in Mexico City Downtown (Figure 8.2). It is worth mentioning that the crack shown in the picture was observed before the seismic event. However, users commented in different twitter posts that its size increased during the earthquake.

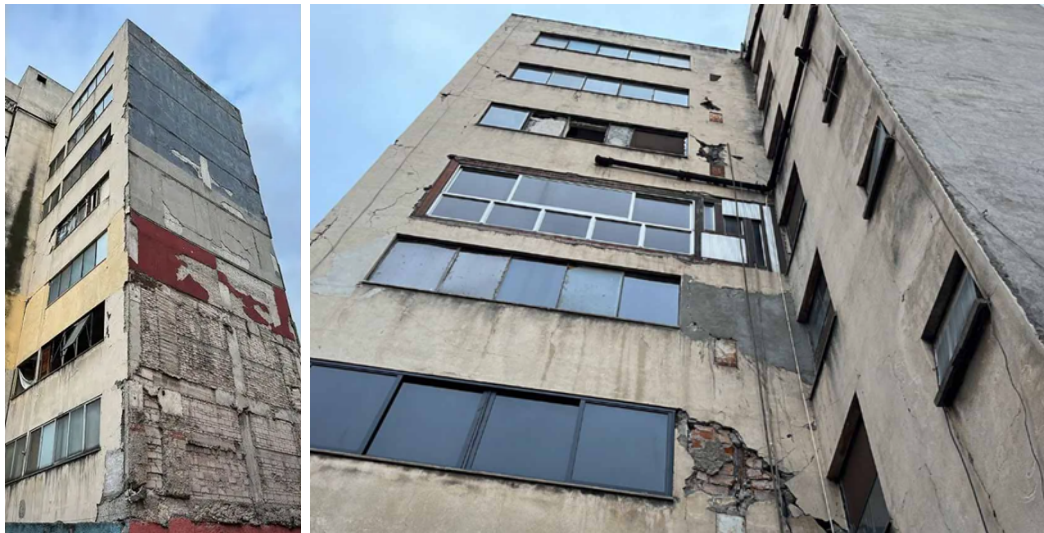
**Figure 8.3. Building located at Doctor Navarro # 182, Alcaldía Cuauhtémoc, Mexico City (Ciudadanos en red, 2022).**

The buildings shown in Figure 8.3 to Figure 8.7 were damaged during the Sep 19, 2017 earthquake, and they have not yet been repaired. In this earthquake (Sep 19, 2022), these buildings reported new damage, including cracking on structural and non-structural walls, broken windows and detached facades.

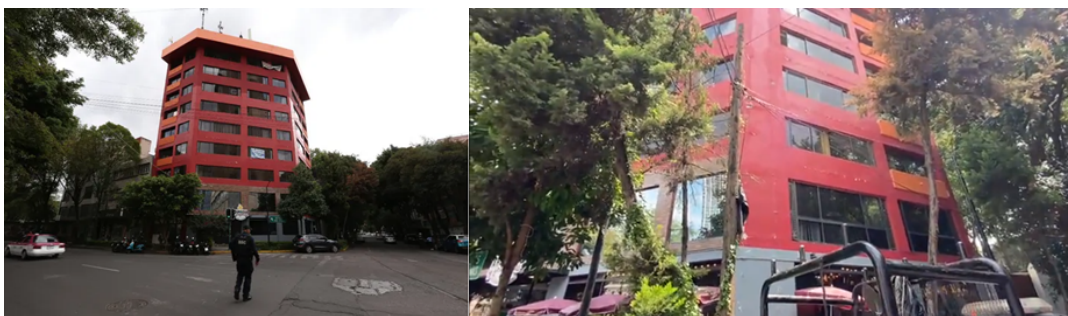
**Figure 8.8. Building in the Juarez neighborhood between Atenas and Versalles Streets (Milenio 2022a and Twitter 2022t).**

Figure 8.8 and Figure 8.9 show two buildings where cracks were observed in the facades after the earthquake. It is unclear whether the observed cracks correspond to structural elements.

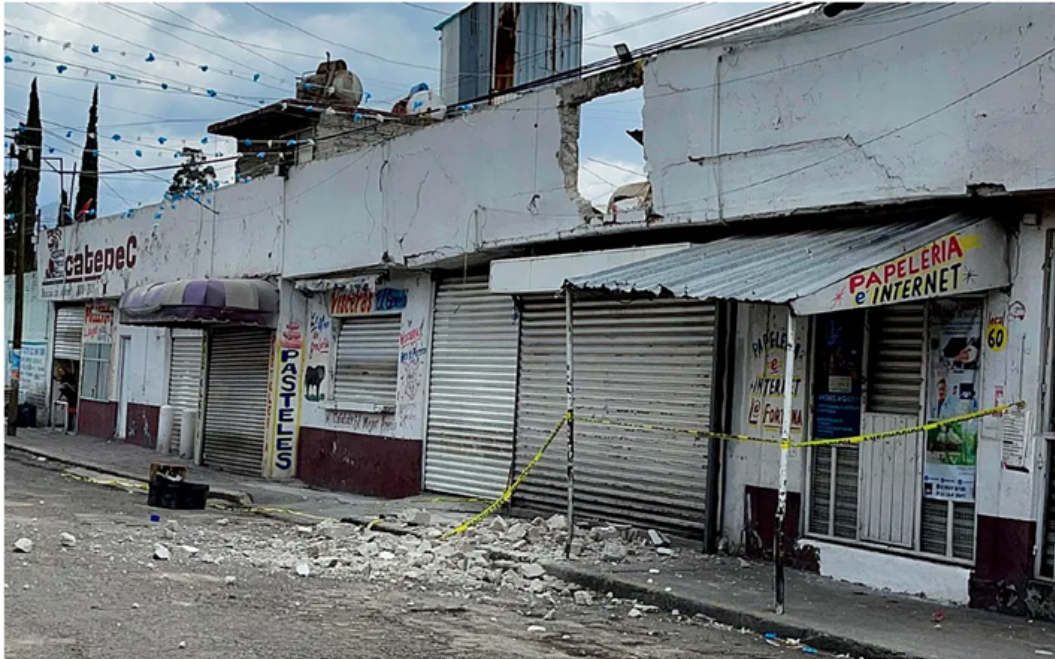
**Figure 8.10. Marketplace “5 de mayo”, in Col. La Michoacána, Ecatepec, State of Mexico (Milenio, 2022b).**

During the seismic event, in Ecatepec, State of Mexico, it was reported that some facade elements had partially collapsed (Figure 8.10). Local firefighters assessed the damage and demolition tasks were carried out on the rest of the elements that presented structural failures.

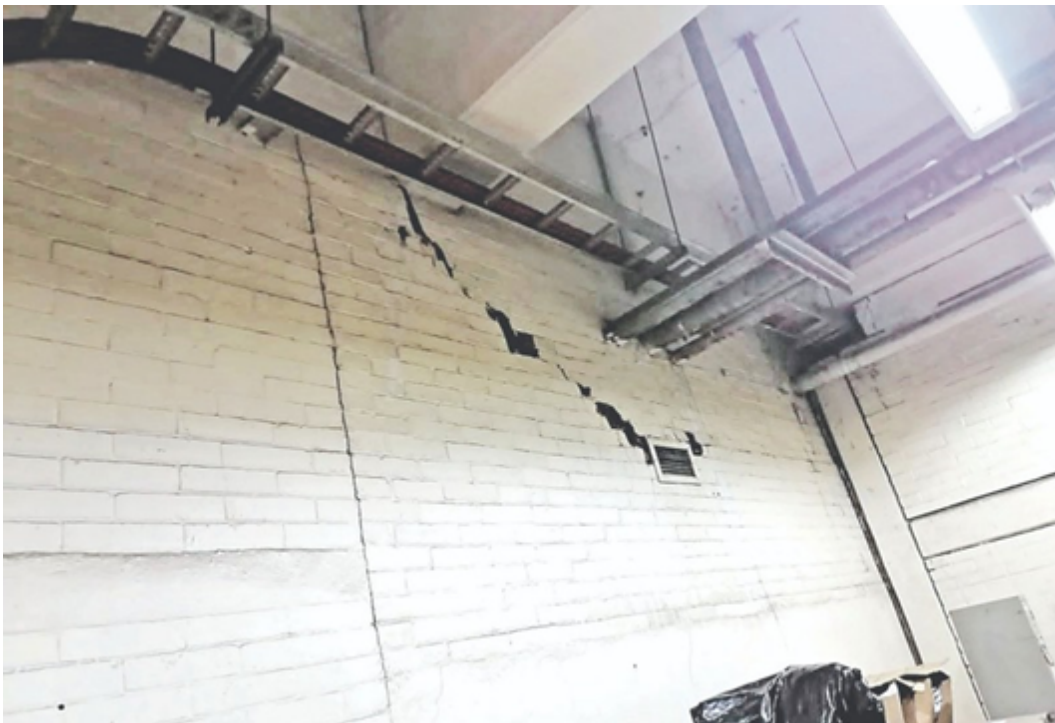
**Figure 8.11. Building in Calle Gral. Gabriel Hernández # 56, Col. Doctores, Cuauhtémoc, Mexico City (Excelsior, 2022b).**

Figure 8.11 to Figure 8.14 show several damaged buildings.

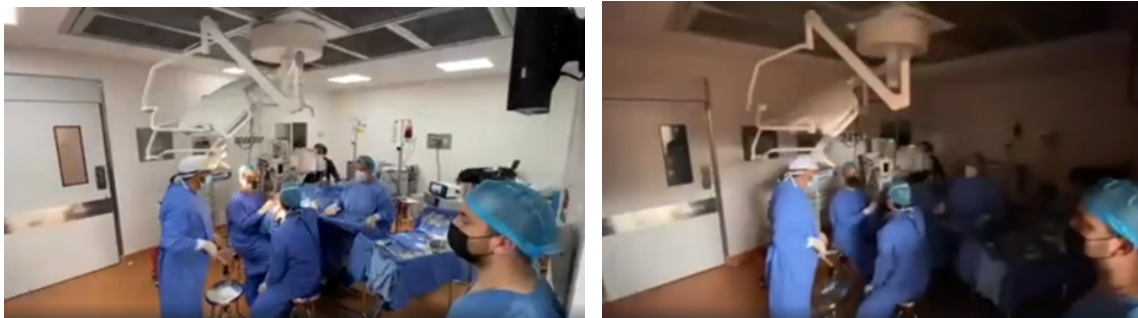
**Figure 8.15. Hospital Siglo XXI, Mexico City (El Heraldo de México, 2022a).**

No damage was reported in the Hospitals of Mexico City and the State of Mexico. However, in the hospital "Siglo XXI" there were failures in the electricity supply, which caused delays to provide medical services. Figure 8.15 shows a photo of an electrical energy supply failure during a baby's surgery, according to information presented by El Heraldo de México (2020a).

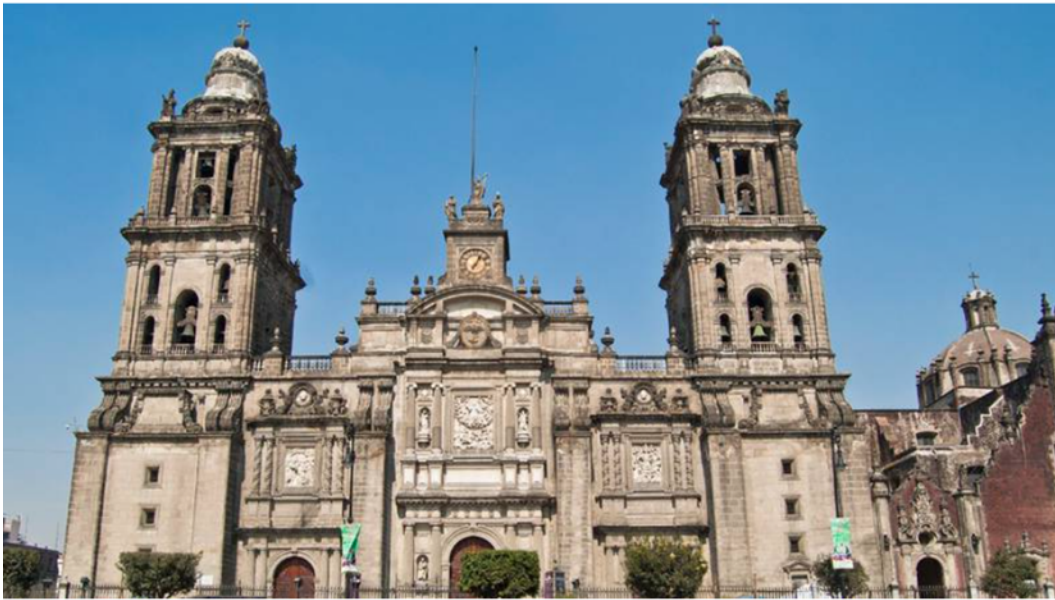
Figure 8.16. Cathedral of Mexico City (El Financiero, 2022b).

The Metropolitan Cathedral of Mexico City (Figure 8.16) did not present visible structural damage. However, people reported material spalling. As a consequence, the facilities were temporarily closed. According to Guatemala Times (2022), the General Directorate of Cultural Heritage Sites and Monuments indicated that current rehabilitation works were suspended in order to carry out a structural review. Reactivation of old cracks in the Metropolitan Sagrario was confirmed.
