# » Continental Europe Synchronous Area Separation on 24 July 2021

ICS Investigation Expert Panel » Final Report » 25 March 2022  
Executive Summary

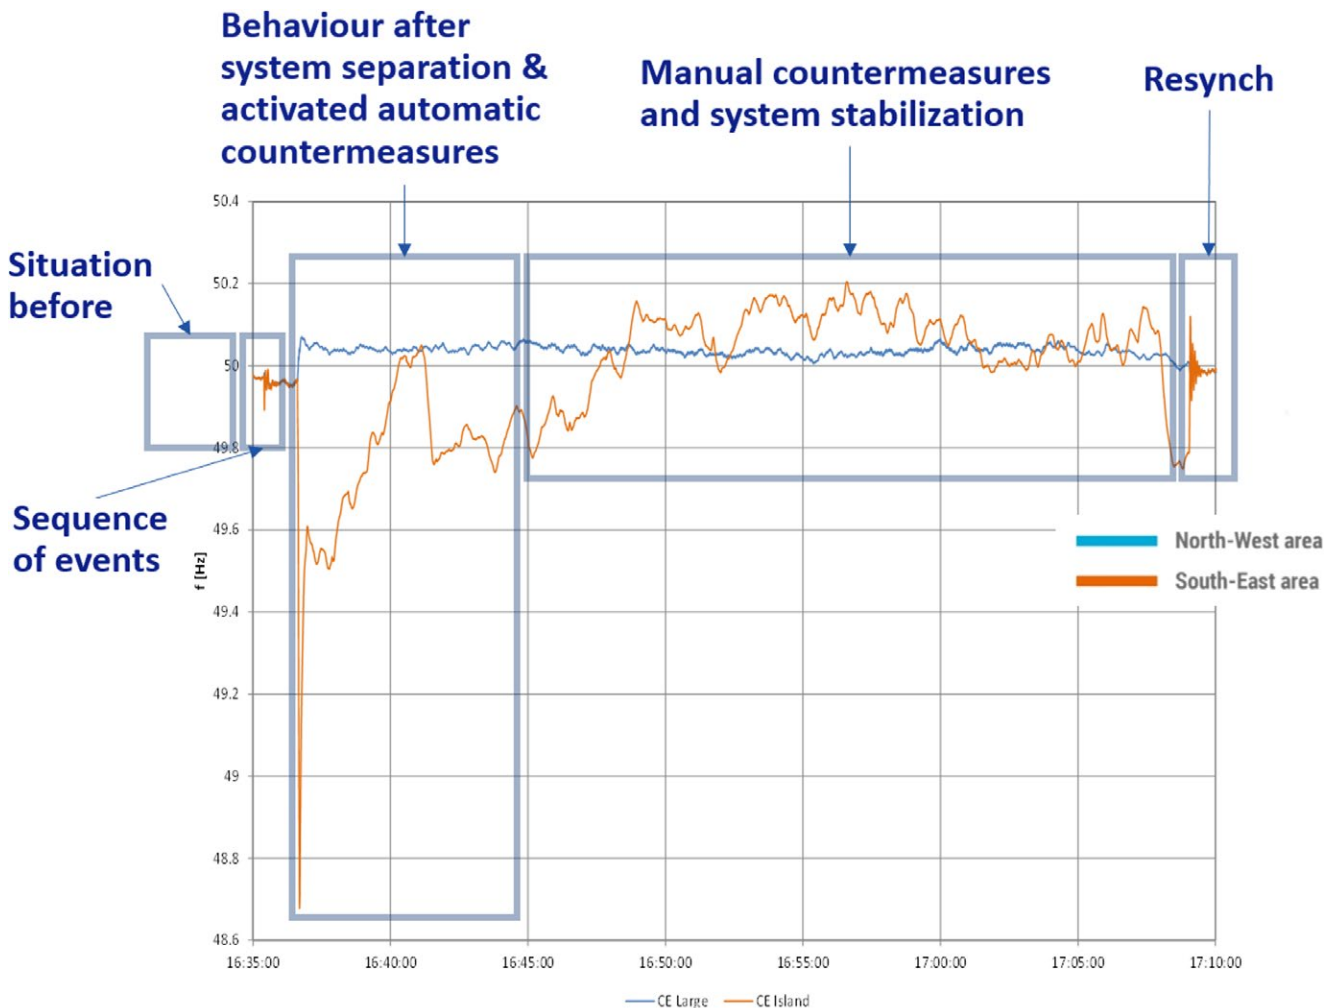
Figure 1: Phases of the system split.

Figure 1 gives a broad overview of the five main phases that occurred during the overall system split:

1. Situation before the event
2. Sequence of events that led to the system split
3. Behaviour after system separation and activation of automatic countermeasures
4. Activation of manual countermeasures and system stabilisation
5. Resynchronisation
